Access Compliance Report

Public Rights-of-Way

(Curb Ramps)

Intersection ID: 10028124	Main Street: HAWFIELD_WAY_DR	Cross Street: N/A	Location: SW
ADA ID: 0A3BC348638E	Ramp Type: Perp	Initial Pass/Fail: Fail	Overall Compliance: No
Codes/Mitigation Info/Possible Solution		Field Measurements/Component Compliance

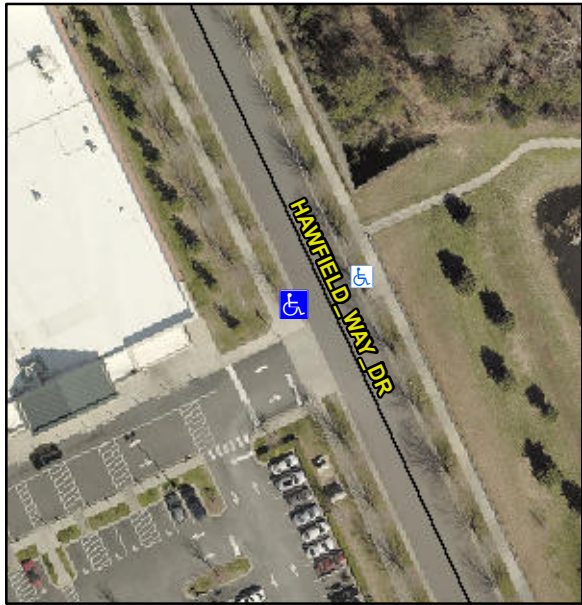
Compliance	Description	Data	Compliance	Description	Data
N/A	Ramp Length (in)	94.0	No	Ramp Slope (%)	10.8
No	Ramp Width (in)	47.5	Yes	Ramp XSlope (%)	2.0
N/A	Flare Type LT	N/A	N/A	Flare Type RT	N/A
N/A	Flare Slope LT (%)	N/A	N/A	Flare Slope RT (%)	N/A
N/A	Flare Traversable LT?	N/A	N/A	Flare Traversable RT?	N/A
N/A	Landing Length (in)	N/A	N/A	DWS Provided?	N/A
N/A	Landing Width (in)	N/A	N/A	DWS Contrast?	N/A
N/A	Landing Slope (%)	N/A	N/A	DWS Length (in)	N/A
N/A	Landing X Slope (%)	N/A	N/A	DWS Full Width?	N/A
N/A	Landing Curb? (Y/N)	N/A	N/A	DWS Offset (in)	N/A
N/A	Shared Landing?	N/A			
N/A	Gutter Ponding?	N/A	N/A	Gutter Slope (%)	N/A
N/A	Gutter Lip Ht (in)	N/A	N/A	Gutter X Slope (%)	N/A
N/A	Painted X Walk1?	No	N/A	Painted X Walk2?	N/A
	X Walk 1 Direction	To NE		X Walk 2 Direction	N/A
N/A	X Walk 1 Width (in)	N/A	N/A	X Walk 2 Width (in)	N/A
	X Walk 1 Slope (%)	2.2		X Walk 2 Slope (%)	N/A
	X Walk 1 X Slope (%)	3.1		X Walk 2 X Slope (%)	N/A

N/A	Ramp inside XWalk1?	N/A	N/A	Ramp inside XWalk2?	N/A
	Road Slope (%)	N/A	N/A	Clear Space?	N/A
	Road X Slope (%)	N/A	N/A	Clear Space to XWalk (in)	N/A
N/A	Any Obstructions?	N/A	N/A	Storm Grate/Utility Hazard?	N/A
	Obstruction Type			Storm Grate/Utility Type	
		N/A			N/A
			Yes	Surface Condition? (G/P)	Good

Possible Solutions:					
	Remove & Replace Entire Ramp.					
	Surveyor Notes:					
	N/A					
	PROW/ADA:					
	R304.5.1, R304.2.2					
	Street 1 Name			HAWFIELD WAY DR		
	Stop Condition-Street 2			None		
	Street 2 Name			N/A		
	Stop Condition-Street 1			N/A		
Total Cost:			\$	1850.00
