# Access Compliance Report

## Public Rights-of-Way

Intersection ID: 14426	Main Street: WEDDINGTON_AV	Cross Street: RANIER_AV	Location: NE
ADA ID: 0A3FB038723C	Ramp Type: PerpDiag	Initial Pass/Fail: Fail	Overall Compliance: No
Codes/Mitigation Info/Possible Solution		Field Measurements/Component Compliance	
Severity Score: 33.75

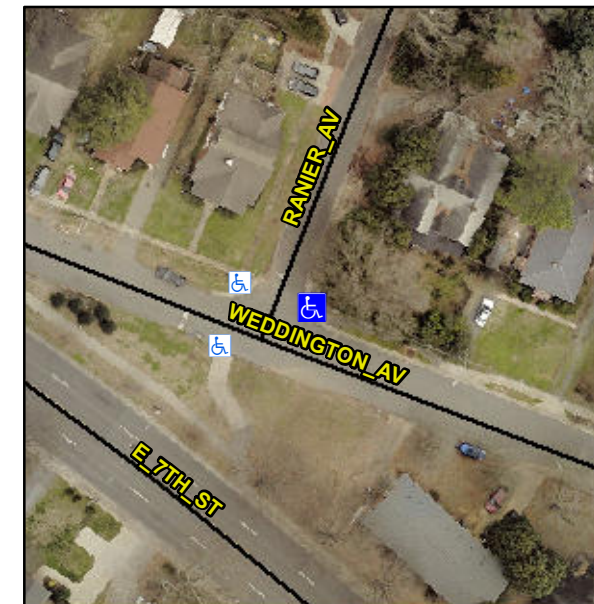
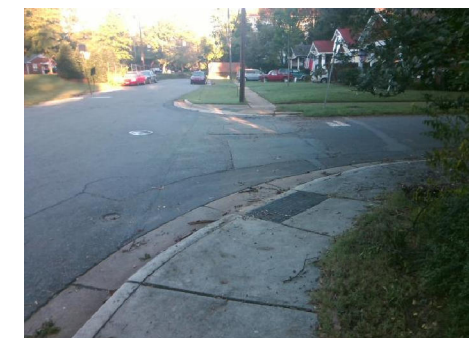
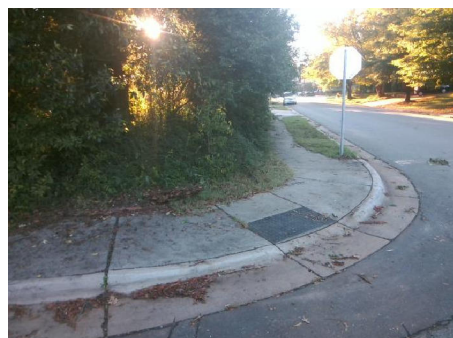
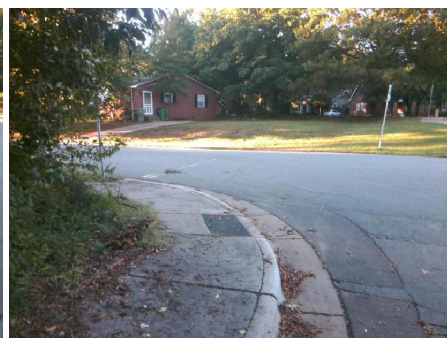
**Not Found, R304.5.1, R304.2.2, R304.5.3**

Compliance	Description	Data	Compliance	Description	Data
N/A	Ramp Length (in)	59.0	No	Ramp Slope (%)	9.2
No	Ramp Width (in)	45.0	No	Ramp XSlope (%)	6.1
N/A	Flare Type LT	N/A	N/A	Flare Type RT	N/A
N/A	Flare Slope LT (%)	N/A	N/A	Flare Slope RT (%)	N/A
N/A	Flare Traversable LT?	N/A	N/A	Flare Traversable RT?	N/A
N/A	Landing Length (in)	N/A	N/A	DWS Provided?	N/A
N/A	Landing Width (in)	N/A	N/A	DWS Contrast?	N/A
N/A	Landing Slope (%)	N/A	N/A	DWS Length (in)	N/A
N/A	Landing X Slope (%)	N/A	N/A	DWS Full Width?	N/A
N/A	Landing Curb? (Y/N)	N/A	N/A	DWS Offset (in)	N/A
N/A	Shared Landing?	N/A			
N/A	Gutter Ponding?	N/A	N/A	Gutter Slope (%)	N/A
N/A	Gutter Lip Ht (in)	N/A	N/A	Gutter X Slope (%)	N/A
N/A	Painted X Walk1?	No	N/A	Painted X Walk2?	No
	X Walk 1 Direction	To SW		X Walk 2 Direction	To NW
N/A	X Walk 1 Width (in)	N/A	N/A	X Walk 2 Width (in)	N/A
	X Walk 1 Slope (%)	5.2		X Walk 2 Slope (%)	4.8
	X Walk 1 X Slope (%)	0.3		X Walk 2 X Slope (%)	3.2

N/A	Ramp inside XWalk1?	N/A	N/A	Ramp inside XWalk2?	N/A
	Road Slope (%)	1.3	N/A	Clear Space?	N/A
	Road X Slope (%)	3.4	N/A	Clear Space to XWalk (in)	N/A
N/A	Any Obstructions?	N/A	N/A	Storm Grate/Utility Hazard?	N/A
	Obstruction Type			Storm Grate/Utility Type	
		N/A			N/A
			Yes	Surface Condition? (G/P)	Good

**Remove & Replace Curb Ramp With Two New Directional Ramps or Equivalent.**
