# Access Compliance Report

## Public Rights-of-Way

### (Curb Ramps)

Intersection ID: 19602	Main Street: VILLAGE_LAKE_DR	Cross Street: CEDAR_GLEN_DR	Location:	N
ADA ID: 0A40F59071C2	Ramp Type: Directional1	Initial Pass/Fail: Fail	Overall Compliance: No	Severity Score: 12.5

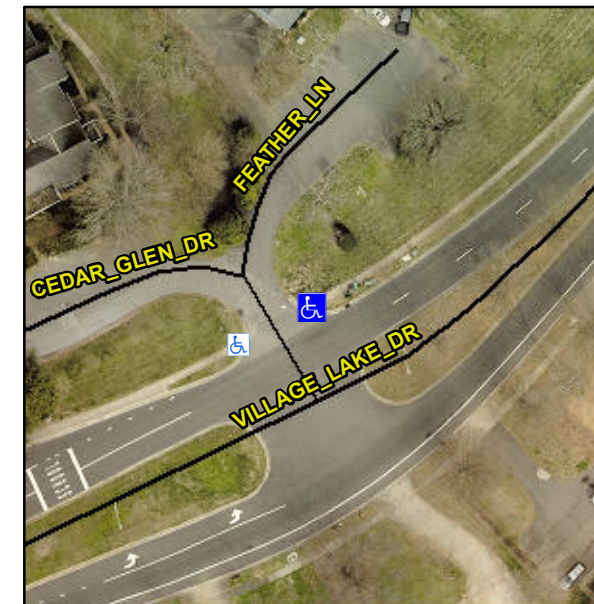
**R304.5.3**

Compliance	Description	Data	Compliance	Description	Data
N/A	Ramp Length (in)	67.0	N/A	Grade Break?	N/A
Yes	Ramp Width (in)	48.0	N/A	Grade Break Slope (%)	0.0
Yes	Ramp Slope (%)	0.9	N/A	Grade Break XSlope (%)	0.0
No	Ramp XSlope (%)	6.2			
N/A	Flare Type LT	N/A	N/A	Flare Type RT	N/A
N/A	Flare Slope LT (%)	N/A	N/A	Flare Slope RT (%)	0.0
N/A	Flare Traversable LT?	N/A	N/A	Flare Traversable RT?	N/A
N/A	Landing Length (in)	0.0	N/A	DWS Provided?	N/A
N/A	Landing Width (in)	0.0	N/A	DWS Contrast?	N/A
N/A	Landing Slope (%)	0.0	N/A	DWS Length (in)	N/A
N/A	Landing X Slope (%)	0.0	N/A	DWS Full Width?	N/A
N/A	Landing Curb? (Y/N)	N/A	N/A	DWS Offset LT (in)	N/A
N/A	Shared Landing?	N/A	N/A	DWS Offset RT (in)	N/A
N/A	Gutter Ponding?	0.0	N/A	Gutter Slope (%)	N/A
N/A	Gutter Lip Ht (in)	0.0	N/A	Gutter X Slope (%)	N/A
N/A	Painted X Walk1?	No		Road Slope (%)	3.9
	X Walk 1 Direction	To SW		Road X Slope (%)	2.6
	X Walk 1 Width (in)	N/A		Clear Space?	N/A

X Walk 1 Slope (%)	3.9	N/A	Clear Space to XWalk (in)	N/A
	X Walk 1 X Slope (%)	2.6	N/A	Storm Grate/Utility Hazard?	N/A
N/A	Ramp inside XWalk1?	N/A		Storm Grate/Utility Type	
N/A	Any Obstructions?	N/A			N/A
	Obstruction Type		Yes	Surface Condition? (G/P)	Good
			N/A	Curb Slope (%)	7.1

**Remove & Replace Entire Ramp.**

Total Cost: \$ 1600.00
