Intersection ID: 10028232	Main Street: HEBRON_COMMERCE_DR	Cross Street: N/A	Location:	SE
ADA ID: 0A465F0E49D5	Ramp Type: PerpDiag	Initial Pass/Fail: Fail	Overall Compliance: No	Severity Score: 33.75

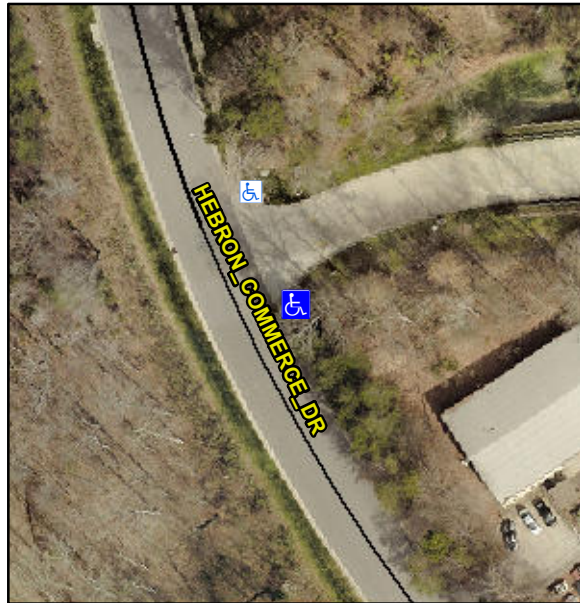
R304.5.1, R304.5.3

Compliance	Description	Data	Compliance	Description	Data
N/A	Ramp Length (in)	60.0	Yes	Ramp Slope (%)	5.7
No	Ramp Width (in)	46.5	No	Ramp XSlope (%)	8.3
N/A	Flare Type LT	N/A	N/A	Flare Type RT	N/A
N/A	Flare Slope LT (%)	N/A	N/A	Flare Slope RT (%)	N/A
N/A	Flare Traversable LT?	N/A	N/A	Flare Traversable RT?	N/A
N/A	Landing Length (in)	N/A	N/A	DWS Provided?	N/A
N/A	Landing Width (in)	N/A	N/A	DWS Contrast?	N/A
N/A	Landing Slope (%)	N/A	N/A	DWS Length (in)	N/A
N/A	Landing X Slope (%)	N/A	N/A	DWS Full Width?	N/A
N/A	Landing Curb? (Y/N)	N/A	N/A	DWS Offset (in)	N/A
N/A	Shared Landing?	N/A			
N/A	Gutter Ponding?	N/A	N/A	Gutter Slope (%)	N/A
N/A	Gutter Lip Ht (in)	N/A	N/A	Gutter X Slope (%)	N/A
N/A	Painted X Walk1?	No	N/A	Painted X Walk2?	No
	X Walk 1 Direction	To N		X Walk 2 Direction	To W
N/A	X Walk 1 Width (in)	N/A	N/A	X Walk 2 Width (in)	N/A
	X Walk 1 Slope (%)	6.5		X Walk 2 Slope (%)	6.2
	X Walk 1 X Slope (%)	3.6		X Walk 2 X Slope (%)	5.7

N/A	Ramp inside XWalk1?	N/A	N/A	Ramp inside XWalk2?	N/A
	Road Slope (%)	8.4	N/A	Clear Space?	N/A
	Road X Slope (%)	2.6	N/A	Clear Space to XWalk (in)	N/A
N/A	Any Obstructions?	N/A	N/A	Storm Grate/Utility Hazard?	N/A
	Obstruction Type			Storm Grate/Utility Type	
		N/A			N/A
			Yes	Surface Condition? (G/P)	Good

Remove & Replace Curb Ramp With Two New Directional Ramps or Equivalent.

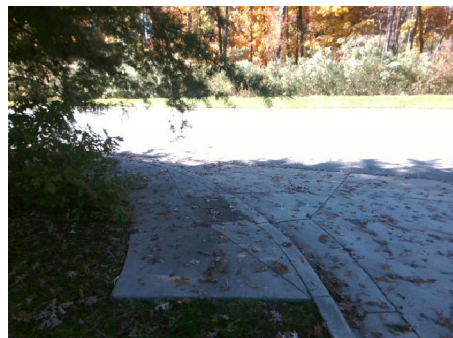
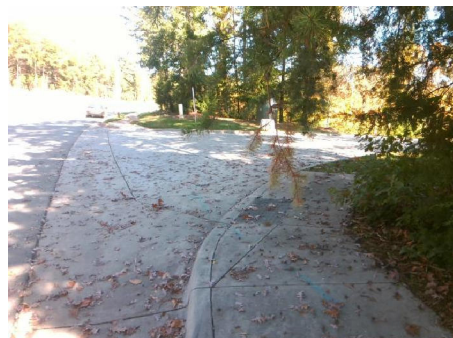
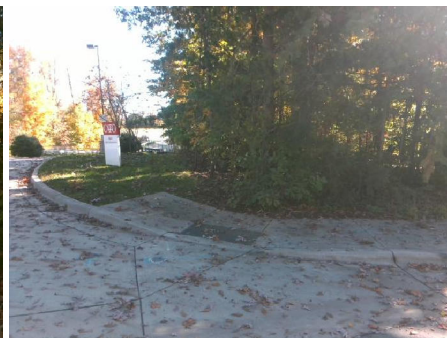
Street 1 Name	ENTRANCE
Stop Condition-Street 2	StopSign
Street 2 Name	HEBRON COMMERCE DR
Stop Condition-Street 1	None
