# Access Compliance Report

## Public Rights-of-Way

### (Curb Ramps)

| Intersection ID: 17925 | Main Street: CROSS_WINDS_RD | Cross Street: IDLEWILD_RD | Location: NW |

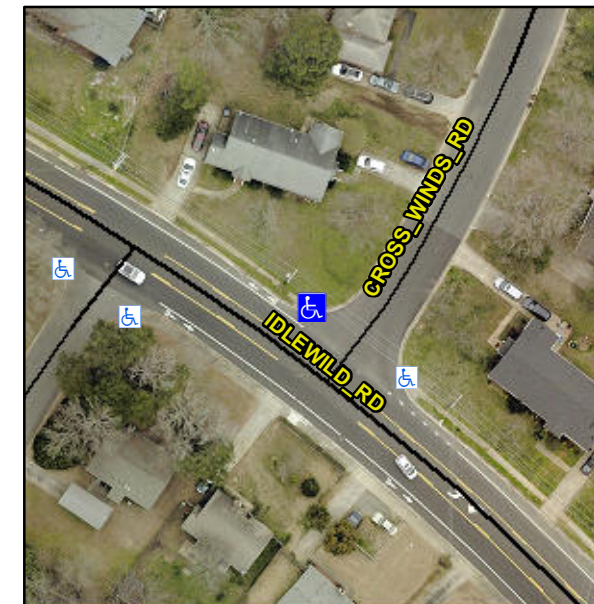
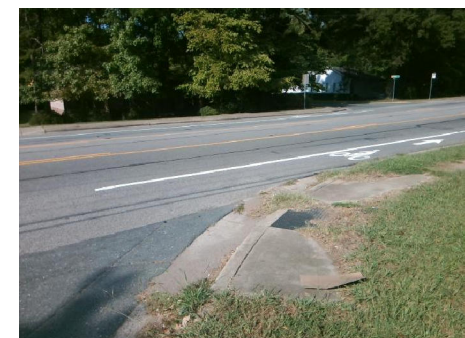
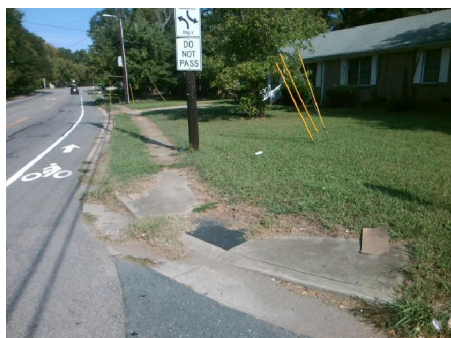
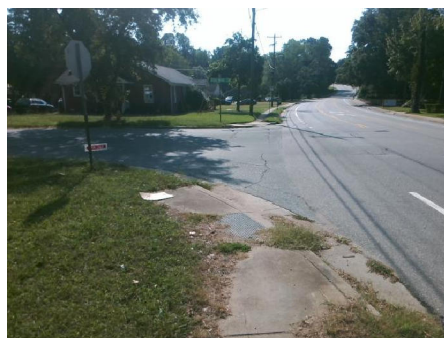
| ADA ID: 0A530A695FAA | Ramp Type: BlendTrans2 | Initial Pass/Fail: Pass | Overall Compliance: No |

**Not Found, R304.5.3**

| Compliance | Description | Data | Compliance | Description | Data |
|---|---|---|---|---|---|
| Yes | Gutter Lip Ht (in) | 0.0 | No | Gutter X Slope (%) | 2.6 |
| | | | No | Curb Slope (%) | 14.7 |

**Remove & Replace Curb Slope and Extend Ramp. Remove & Replace Gutter.**

Total Cost: \$ 2750.00
