Access Compliance Report

Public Rights-of-Way

(Curb Ramps)

Intersection ID: 10022675	Main Street: CARNEGIE_BV	Cross Street: N/A	Location: N
ADA ID: 0A5450B9E907	Ramp Type: Perp	Initial Pass/Fail: Pass	Overall Compliance: No
Severity Score: 15.25			
Codes/Mitigation Info/Possible Solution		Field Measurements/Component Compliance

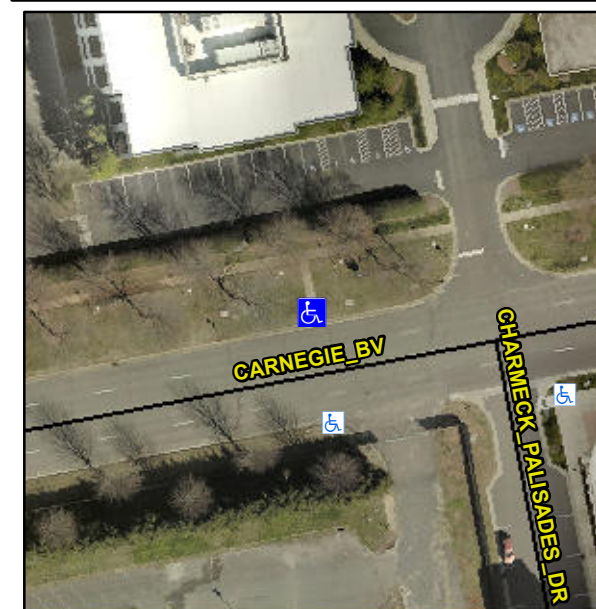
Compliance	Description	Data	Compliance	Description	Data
N/A	Ramp Length (in)	129.0	Yes	Ramp Slope (%)	6.6
Yes	Ramp Width (in)	58.0	No	Ramp XSlope (%)	2.5
N/A	Flare Type LT	None	N/A	Flare Type RT	N/A
N/A	Flare Slope LT (%)	N/A	N/A	Flare Slope RT (%)	N/A
N/A	Flare Traversable LT?	N/A	N/A	Flare Traversable RT?	N/A
Yes	Landing Length (in)	66.0	No	DWS Provided?	No
Yes	Landing Width (in)	58.0	N/A	DWS Contrast?	No
Yes	Landing Slope (%)	2.0	N/A	DWS Length (in)	N/A
Yes	Landing X Slope (%)	1.3	N/A	DWS Full Width?	No
N/A	Landing Curb? (Y/N)	No	N/A	DWS Offset (in)	N/A
N/A	Shared Landing?	No			
Yes	Gutter Ponding?	No	No	Gutter Slope (%)	6.2
Yes	Gutter Lip Ht (in)	0.0	Yes	Gutter X Slope (%)	0.3
N/A	Painted X Walk1?	No	N/A	Painted X Walk2?	N/A
	X Walk 1 Direction	To S		X Walk 2 Direction	N/A
N/A	X Walk 1 Width (in)	N/A	N/A	X Walk 2 Width (in)	N/A
	X Walk 1 Slope (%)	2.4		X Walk 2 Slope (%)	N/A
	X Walk 1 X Slope (%)	1.0		X Walk 2 X Slope (%)	N/A

N/A	Ramp inside XWalk1?	N/A	N/A	Ramp inside XWalk2?	N/A
	Road Slope (%)	N/A	N/A	Clear Space?	Yes
	Road X Slope (%)	N/A	N/A	Clear Space to XWalk (in)	N/A
Yes	Any Obstructions?	No	Yes	Storm Grate/Utility Hazard?	No
	Obstruction Type			Storm Grate/Utility Type	
			N/A		N/A
			Yes	Surface Condition? (G/P)	Good

**Remove & Replace Entire Ramp.
Remove & Replace Gutter.**
