Access Compliance Report Public Rights-of-Way (Curb Ramps)

Intersection ID: 44953 Main Street: GOODLOE DR **Cross Street: OLDCORN LN** Location: Severity Score: 46.25 ADA ID: 0A5FAA5FAD68 Ramp Type: PerpDiag Initial Pass/Fail: Fail **Overall Compliance: No**

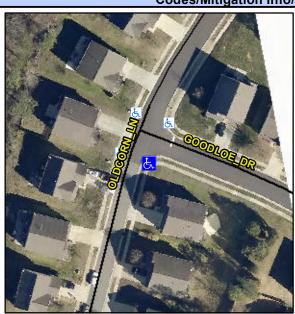
| Field Measurements/Component Compliance | | | | | |
|---|---|---|---|---|---|
| N/A | Ramp Length (in) | 48.0 | No | Ramp Slope (%) | 9.0 |
| No | Ramp Width (in) | 45.0 | No | Ramp XSlope (%) | 11.2 |

Possible Solutions: Remove & Replace Curb Ramp With Two New Directional Ramps or Equivalent. Surveyor Notes: N/A PROW/ADA: Not Found, R304.5.1, R304.2.2, R304.5.3

Total Cost: 3200.00
