Access Compliance Report

Public Rights-of-Way

(Curb Ramps)

Intersection ID: 43663	Main Street: TAYLOR_RIDGE_LN	Cross Street: HUNTINGTON_MEADOW_LN	Location: NW
ADA ID: 0A619403685A	Ramp Type: PerpDiag	Initial Pass/Fail: Fail	Overall Compliance: No
Severity Score: 22.5			
Codes/Mitigation Info/Possible Solution		Field Measurements/Component Compliance

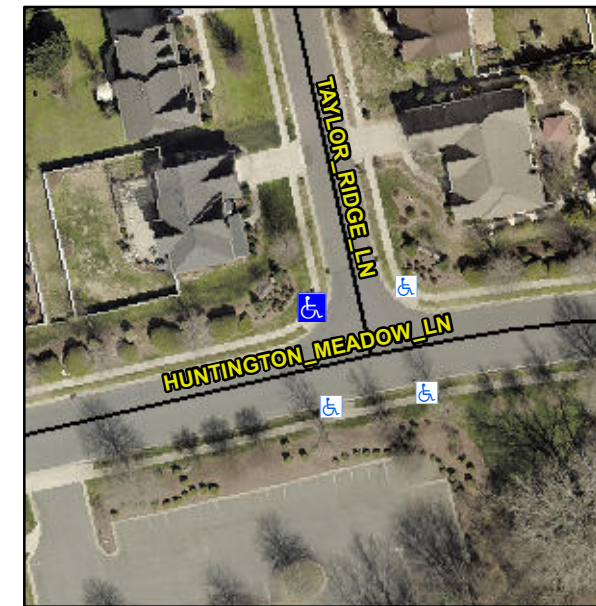
Not Found, R304.5.1, R304.2.2, R304.5.3

Compliance	Description	Data	Compliance	Description	Data
N/A	Ramp Length (in)	47.5	No	Ramp Slope (%)	9.7
No	Ramp Width (in)	44.0	No	Ramp XSlope (%)	2.3
N/A	Flare Type LT	N/A	N/A	Flare Type RT	N/A
N/A	Flare Slope LT (%)	N/A	N/A	Flare Slope RT (%)	N/A
N/A	Flare Traversable LT?	N/A	N/A	Flare Traversable RT?	N/A
N/A	Landing Length (in)	N/A	N/A	DWS Provided?	N/A
N/A	Landing Width (in)	N/A	N/A	DWS Contrast?	N/A
N/A	Landing Slope (%)	N/A	N/A	DWS Length (in)	N/A
N/A	Landing X Slope (%)	N/A	N/A	DWS Full Width?	N/A
N/A	Landing Curb? (Y/N)	N/A	N/A	DWS Offset (in)	N/A
N/A	Shared Landing?	N/A			
N/A	Gutter Ponding?	N/A	N/A	Gutter Slope (%)	N/A
N/A	Gutter Lip Ht (in)	N/A	N/A	Gutter X Slope (%)	N/A
N/A	Painted X Walk1?	No	N/A	Painted X Walk2?	No
	X Walk 1 Direction	To S		X Walk 2 Direction	To E
N/A	X Walk 1 Width (in)	N/A	N/A	X Walk 2 Width (in)	N/A
	X Walk 1 Slope (%)	2.9		X Walk 2 Slope (%)	2.3
	X Walk 1 X Slope (%)	3.5		X Walk 2 X Slope (%)	1.5

N/A	Ramp inside XWalk1?	N/A	N/A	Ramp inside XWalk2?	N/A
	Road Slope (%)	0.5	N/A	Clear Space?	N/A
	Road X Slope (%)	6.2	N/A	Clear Space to XWalk (in)	N/A
N/A	Any Obstructions?	N/A	N/A	Storm Grate/Utility Hazard?	N/A
	Obstruction Type			Storm Grate/Utility Type	
		N/A			N/A
			Yes	Surface Condition? (G/P)	Good

Remove & Replace Curb Ramp With Two New Directional Ramps or Equivalent.

Total Cost: \$ 3200.00
