Access Compliance Report

Public Rights-of-Way

(Curb Ramps)

Intersection ID: N/A	Main Street: PROVIDENCE_RD	Cross Street: N/A	Location: SW
ADA ID: 0A6CC965D763	Ramp Type: ParaDiag	Initial Pass/Fail: Fail	Overall Compliance: No
		Severity Score: 12.5

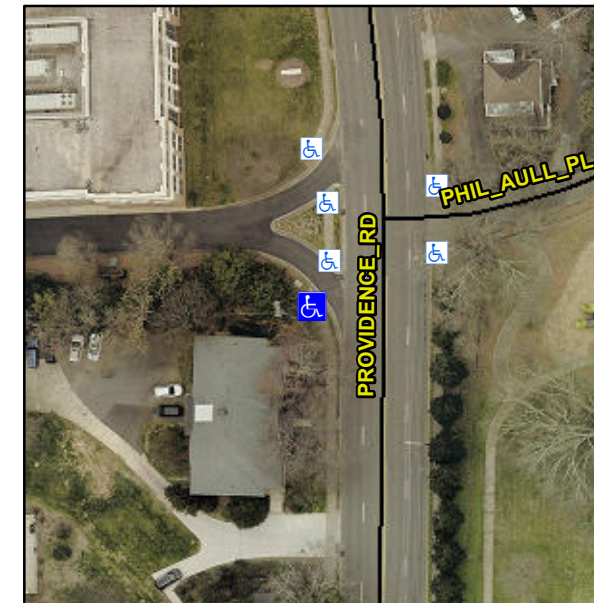
Compliance	Description	Data	Compliance	Description	Data
N/A	Ramp Length LT (in)	N/A	N/A	Ramp Length RT (in)	73.0
N/A	Ramp Width LT (in)	N/A	Yes	Ramp Width RT (in)	83.0
N/A	Ramp Slope LT (%)	N/A	No	Ramp Slope RT (%)	10.4
N/A	Ramp XSlope LT (%)	N/A	Yes	Ramp XSlope RT (%)	1.0
N/A	Landing Length (in)	N/A	N/A	DWS Provided?	N/A
N/A	Landing Width (in)	N/A	N/A	DWS Contrast?	N/A
N/A	Landing Slope (%)	N/A	N/A	DWS Length (in)	N/A
N/A	Landing X Slope (%)	N/A	N/A	DWS Full Width?	N/A
N/A	Landing Curb? (Y/N)	N/A	N/A	DWS Offset (in)	N/A
N/A	Shared Landing?	N/A			
N/A	Gutter Ponding?	N/A	N/A	Gutter Slope (%)	N/A
N/A	Gutter Lip Ht (in)	N/A	N/A	Gutter X Slope (%)	N/A
N/A	Painted X Walk1?	No	N/A	Painted X Walk2?	No
	X Walk 1 Direction	To NE		X Walk 2 Direction	To N
N/A	X Walk 1 Width (in)	N/A	N/A	X Walk 2 Width (in)	N/A
	X Walk 1 Slope (%)	3.0		X Walk 2 Slope (%)	1.5
	X Walk 1 X Slope (%)	4.4		X Walk 2 X Slope (%)	2.4
N/A	Ramp inside XWalk1?	N/A	N/A	Ramp inside XWalk2?	N/A

Road Slope (%)	3.4	N/A	Clear Space?	N/A
	Road X Slope (%)	4.0	N/A	Clear Space to XWalk (in)	N/A
N/A	Any Obstructions?	N/A	N/A	Storm Grate/Utility Hazard?	N/A
	Obstruction Type			Storm Grate/Utility Type	
		N/A			N/A
			Yes	Surface Condition? (G/P)	Good
			N/A	Curb Slope (%)	3.5

Remove & Replace Curb Ramp With Two New Directional Ramps or Equivalent.

R304.3.2

\$ 3200.00
