Access Compliance Report

Public Rights-of-Way

(Curb Ramps)

Intersection ID: 31282	Main Street: MALLARD_GLEN_DR	Cross Street: TIGER_LN	Location: NW
ADA ID: 0A6CEF4E1AC0	Ramp Type: PerpDiag	Initial Pass/Fail: Fail	Overall Compliance: No
		Severity Score: 12.5

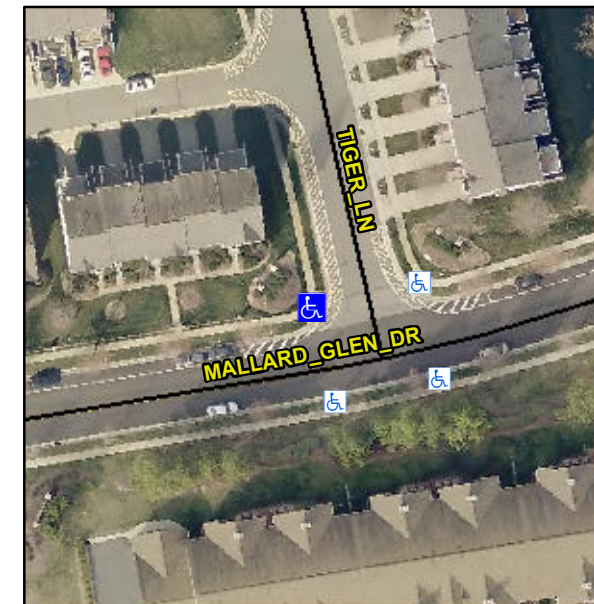
Compliance	Description	Data	Compliance	Description	Data
N/A	Ramp Length (in)	56.5	No	Ramp Slope (%)	11.2
Yes	Ramp Width (in)	53.5	Yes	Ramp XSlope (%)	1.9
N/A	Flare Type LT	N/A	N/A	Flare Type RT	N/A
N/A	Flare Slope LT (%)	N/A	N/A	Flare Slope RT (%)	N/A
N/A	Flare Traversable LT?	N/A	N/A	Flare Traversable RT?	N/A
N/A	Landing Length (in)	N/A	N/A	DWS Provided?	N/A
N/A	Landing Width (in)	N/A	N/A	DWS Contrast?	N/A
N/A	Landing Slope (%)	N/A	N/A	DWS Length (in)	N/A
N/A	Landing X Slope (%)	N/A	N/A	DWS Full Width?	N/A
N/A	Landing Curb? (Y/N)	N/A	N/A	DWS Offset (in)	N/A
N/A	Shared Landing?	N/A			
N/A	Gutter Ponding?	N/A	N/A	Gutter Slope (%)	N/A
N/A	Gutter Lip Ht (in)	N/A	N/A	Gutter X Slope (%)	N/A
N/A	Painted X Walk1?	No	N/A	Painted X Walk2?	No
	X Walk 1 Direction	To S		X Walk 2 Direction	To E
N/A	X Walk 1 Width (in)	N/A	N/A	X Walk 2 Width (in)	N/A
	X Walk 1 Slope (%)	1.9		X Walk 2 Slope (%)	2.4
	X Walk 1 X Slope (%)	1.9		X Walk 2 X Slope (%)	0.4

N/A	Ramp inside XWalk1?	N/A	N/A	Ramp inside XWalk2?	N/A
	Road Slope (%)	0.7	N/A	Clear Space?	N/A
	Road X Slope (%)	3.9	N/A	Clear Space to XWalk (in)	N/A
N/A	Any Obstructions?	N/A	N/A	Storm Grate/Utility Hazard?	N/A
	Obstruction Type			Storm Grate/Utility Type	
		N/A			N/A
			Yes	Surface Condition? (G/P)	Good

Remove & Replace Curb Ramp With Two New Directional Ramps or Equivalent.

R304.2.2
