Access Compliance Report

Public Rights-of-Way

(Curb Ramps)

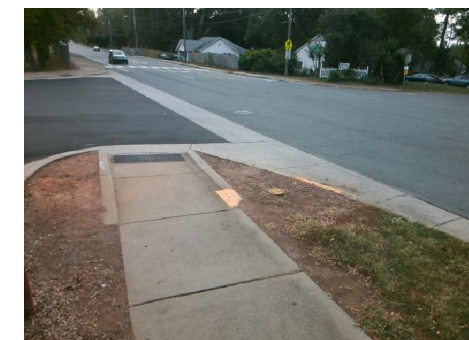
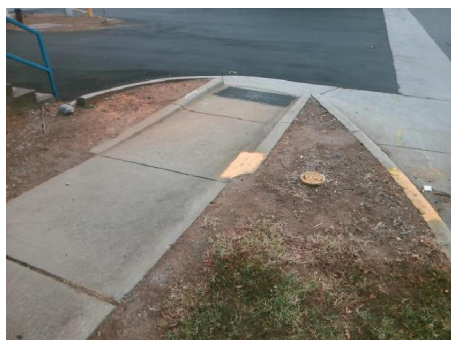
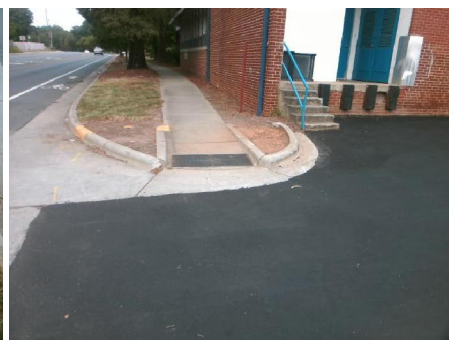
Intersection ID: N/A		Main Street: PENCE_RD		Cross Street: HICKORY_TRACE_DR		Location: NW							
ADA ID: 0A6DF61E475D		Ramp Type: Directional1		Initial Pass/Fail: Pass		Overall Compliance: No		Severity Score: 0.25					
Codes/Mitigation Info/Possible Solution				Field Measurements/Component Compliance									
<div> </div> <div>Possible Solutions:</div> <div>Remove & Replace Landing.</div> <div>Surveyor Notes:</div> <div>N/A</div> <div>PROW/ADA:</div> <div>R304.2.2-Perp, R304.3.2-Para</div>				Compliance	Description	Data	Compliance	Description	Data				
				N/A	Ramp Length (in)	117.0	Yes	Grade Break?	Yes				
				Yes	Ramp Width (in)	52.0	Yes	Grade Break Slope (%)	1.9				
				Yes	Ramp Slope (%)	3.3	Yes	Grade Break XSlope (%)	2.4				
				Yes	Ramp XSlope (%)	3.6							
				Yes	Flare Type LT	N/A	Yes	Flare Type RT	N/A				
				N/A	Flare Slope LT (%)	N/A	N/A	Flare Slope RT (%)	N/A				
				N/A	Flare Traversable LT?	No	N/A	Flare Traversable RT?	No

Yes	Landing Length (in)	54.0	Yes	DWS Provided?	Yes				
				Yes	Landing Width (in)	55.0	Yes	DWS Contrast?	Yes				
				No	Landing Slope (%)	4.1	Yes	DWS Length (in)	24.0				
				Yes	Landing X Slope (%)	2.6	Yes	DWS Full Width?	Yes				
				N/A	Landing Curb? (Y/N)	N/A	Yes	DWS Offset LT (in)	1.0				
				N/A	Shared Landing?	No	Yes	DWS Offset RT (in)	1.0				
				Yes	Gutter Ponding?	No	Yes	Gutter Slope (%)	2.8				
				Yes	Gutter Lip Ht (in)	0.0	Yes	Gutter X Slope (%)	3.7				
				N/A	Painted X Walk1?	No		Road Slope (%)	2.1				
					X Walk 1 Direction	To E		Road X Slope (%)	3.8				
					X Walk 1 Width (in)	N/A		Clear Space?	Yes				
					X Walk 1 Slope (%)	2.1	N/A	Clear Space to XWalk (in)	N/A				
					X Walk 1 X Slope (%)	3.8	Yes	Storm Grate/Utility Hazard?	No				
				N/A	Ramp inside XWalk1?	N/A		Storm Grate/Utility Type					
				Yes	Any Obstructions?	No			N/A				
					Obstruction Type		Yes	Surface Condition? (G/P)	Good

N/A	Curb Slope (%)	6.5				
				Total Cost:		\$	500.00
