# Access Compliance Report

## Public Rights-of-Way

### (Curb Ramps)

Intersection ID: 45500	Main Street: GRASSY_CROPS_RD	Cross Street: TRIPLE_OAK_RD	Location: SW
ADA ID: 0A75B08B1582	Ramp Type: PerpDiag	Initial Pass/Fail: Fail	Overall Compliance: No
Codes/Mitigation Info/Possible Solution		Field Measurements/Component Compliance	
Severity Score: 48.75

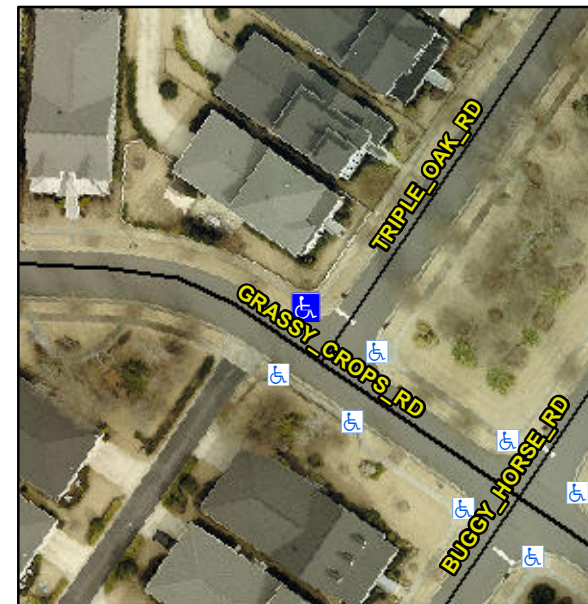
**Not Found, R304.5.1, R304.2.2, R304.5.3**

Compliance	Description	Data	Compliance	Description	Data
N/A	Ramp Length (in)	71.0	No	Ramp Slope (%)	10.8
No	Ramp Width (in)	30.0	No	Ramp XSlope (%)	3.1
N/A	Flare Type LT	N/A	N/A	Flare Type RT	N/A
N/A	Flare Slope LT (%)	N/A	N/A	Flare Slope RT (%)	N/A
N/A	Flare Traversable LT?	N/A	N/A	Flare Traversable RT?	N/A
N/A	Landing Length (in)	N/A	N/A	DWS Provided?	N/A
N/A	Landing Width (in)	N/A	N/A	DWS Contrast?	N/A
N/A	Landing Slope (%)	N/A	N/A	DWS Length (in)	N/A
N/A	Landing X Slope (%)	N/A	N/A	DWS Full Width?	N/A
N/A	Landing Curb? (Y/N)	N/A	N/A	DWS Offset (in)	N/A
N/A	Shared Landing?	N/A			
N/A	Gutter Ponding?	N/A	N/A	Gutter Slope (%)	N/A
N/A	Gutter Lip Ht (in)	N/A	N/A	Gutter X Slope (%)	N/A
N/A	Painted X Walk1?	No	N/A	Painted X Walk2?	No
	X Walk 1 Direction	To SW		X Walk 2 Direction	To SE
N/A	X Walk 1 Width (in)	N/A	N/A	X Walk 2 Width (in)	N/A
	X Walk 1 Slope (%)	1.9		X Walk 2 Slope (%)	3.1
	X Walk 1 X Slope (%)	4.3		X Walk 2 X Slope (%)	3.1

N/A	Ramp inside XWalk1?	N/A	N/A	Ramp inside XWalk2?	N/A
	Road Slope (%)	3.7	N/A	Clear Space?	N/A
	Road X Slope (%)	1.1	N/A	Clear Space to XWalk (in)	N/A
N/A	Any Obstructions?	N/A	N/A	Storm Grate/Utility Hazard?	N/A
	Obstruction Type			Storm Grate/Utility Type	
		N/A			N/A
			Yes	Surface Condition? (G/P)	Good

**Remove & Replace Curb Ramp With Two New Directional Ramps or Equivalent.**

Total Cost: \$ **3200.00**
