# Access Compliance Report

## Public Rights-of-Way

### (Curb Ramps)

Intersection ID: 16141	Main Street: N_WENDOVER_RD	Cross Street: LATROBE_DR	Location: NW
ADA ID: 0A838263B54D	Ramp Type: MedianPerp	Initial Pass/Fail: Fail	Overall Compliance: No
		Severity Score: 22.5

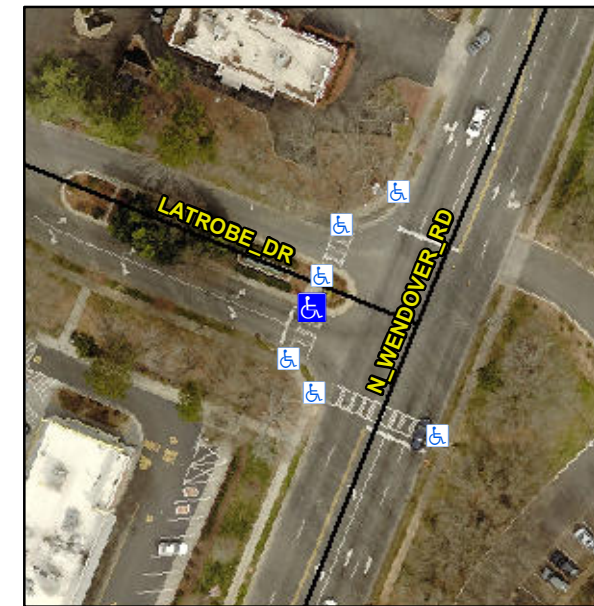
Compliance	Description	Data	Compliance	Description	Data
N/A	Ramp Length (in)	72.0	No	Ramp Slope (%)	8.8
No	Ramp Width (in)	46.0	No	Ramp XSlope (%)	4.3
N/A	Flare Type LT	N/A	N/A	Flare Type RT	N/A
N/A	Flare Slope LT (%)	N/A	N/A	Flare Slope RT (%)	N/A
N/A	Flare Traversable LT?	N/A	N/A	Flare Traversable RT?	N/A
N/A	Landing Length (in)	N/A	N/A	DWS Provided?	N/A
N/A	Landing Width (in)	N/A	N/A	DWS Contrast?	N/A
N/A	Landing Slope (%)	N/A	N/A	DWS Length (in)	N/A
N/A	Landing X Slope (%)	N/A	N/A	DWS Full Width?	N/A
N/A	Landing Curb? (Y/N)	N/A	N/A	DWS Offset (in)	N/A
N/A	Shared Landing?	N/A			
N/A	Gutter Ponding?	N/A	N/A	Gutter Slope (%)	N/A
N/A	Gutter Lip Ht (in)	N/A	N/A	Gutter X Slope (%)	N/A
N/A	Painted X Walk1?	Yes	N/A	Painted X Walk2?	N/A
	X Walk 1 Direction	To SW		X Walk 2 Direction	N/A
N/A	X Walk 1 Width (in)	112.0	N/A	X Walk 2 Width (in)	N/A
	X Walk 1 Slope (%)	1.4		X Walk 2 Slope (%)	N/A
	X Walk 1 X Slope (%)	1.4		X Walk 2 X Slope (%)	N/A

N/A	Ramp inside XWalk1?	Yes	N/A	Ramp inside XWalk2?	N/A
	Road Slope (%)	N/A	N/A	Clear Space?	N/A
	Road X Slope (%)	N/A	N/A	Clear Space to XWalk (in)	N/A
N/A	Any Obstructions?	N/A	N/A	Storm Grate/Utility Hazard?	N/A
	Obstruction Type			Storm Grate/Utility Type	
		N/A			N/A
			Yes	Surface Condition? (G/P)	Good

**Remove & Replace Entire Ramp.**

**R304.5.1, R304.2.2, R304.5.3**
