Intersection ID: 11750	Main Street: MCNINCH_ST	Cross Street: WESTBROOK_DR	Location:	SW
ADA ID: 0A855E55F293	Ramp Type: PerpDiag	Initial Pass/Fail: Fail	Overall Compliance: No	Severity Score: 26.25

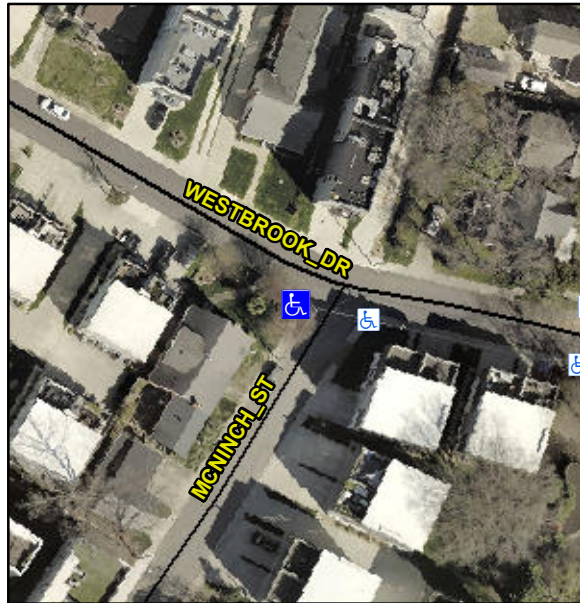
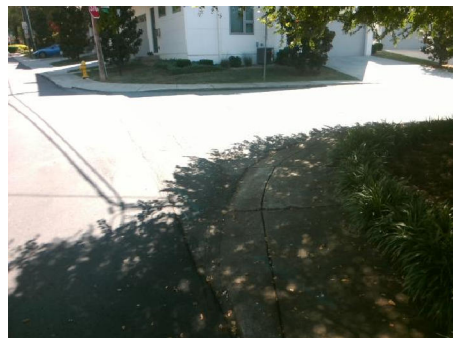
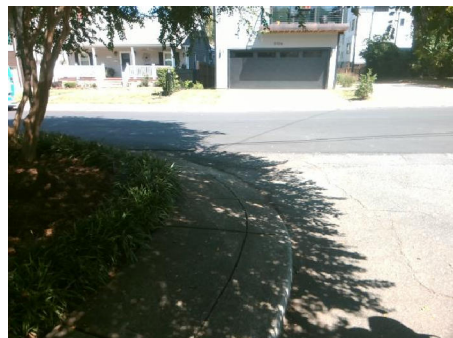
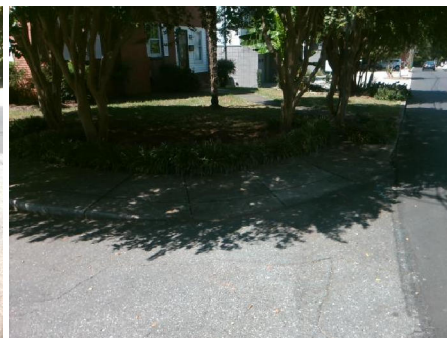
Not Found, R304.2.2, R304.5.3

Compliance	Description	Data	Compliance	Description	Data
N/A	Ramp Length (in)	36.0	No	Ramp Slope (%)	12.9
Yes	Ramp Width (in)	86.0	No	Ramp XSlope (%)	4.5
N/A	Flare Type LT	N/A	N/A	Flare Type RT	N/A
N/A	Flare Slope LT (%)	N/A	N/A	Flare Slope RT (%)	N/A
N/A	Flare Traversable LT?	N/A	N/A	Flare Traversable RT?	N/A
N/A	Landing Length (in)	N/A	N/A	DWS Provided?	N/A
N/A	Landing Width (in)	N/A	N/A	DWS Contrast?	N/A
N/A	Landing Slope (%)	N/A	N/A	DWS Length (in)	N/A
N/A	Landing X Slope (%)	N/A	N/A	DWS Full Width?	N/A
N/A	Landing Curb? (Y/N)	N/A	N/A	DWS Offset (in)	N/A
N/A	Shared Landing?	N/A			
N/A	Gutter Ponding?	N/A	N/A	Gutter Slope (%)	N/A
N/A	Gutter Lip Ht (in)	N/A	N/A	Gutter X Slope (%)	N/A
N/A	Painted X Walk1?	No	N/A	Painted X Walk2?	No
	X Walk 1 Direction	To SE		X Walk 2 Direction	To NW
N/A	X Walk 1 Width (in)	N/A	N/A	X Walk 2 Width (in)	N/A
	X Walk 1 Slope (%)	7.4		X Walk 2 Slope (%)	3.2
	X Walk 1 X Slope (%)	0.9		X Walk 2 X Slope (%)	3.7

N/A	Ramp inside XWalk1?	N/A	N/A	Ramp inside XWalk2?	N/A
	Road Slope (%)	1.4	N/A	Clear Space?	N/A
	Road X Slope (%)	6.8	N/A	Clear Space to XWalk (in)	N/A
N/A	Any Obstructions?	N/A	N/A	Storm Grate/Utility Hazard?	N/A
	Obstruction Type			Storm Grate/Utility Type	
		N/A			N/A
			Yes	Surface Condition? (G/P)	Good

Remove & Replace Curb Ramp With Two New Directional Ramps or Equivalent.
