Access Compliance Report

Public Rights-of-Way (Curb Ramps)

Intersection ID: 47449	Main Street: MALLARD_LANDING_RD	Cross Street: WOOD_DUCK_CROSSING_DR	Location: NW
ADA ID: 0A87CCF0ED82	Ramp Type: Perp	Initial Pass/Fail: Fail	Overall Compliance: No Severity Score: 21.25

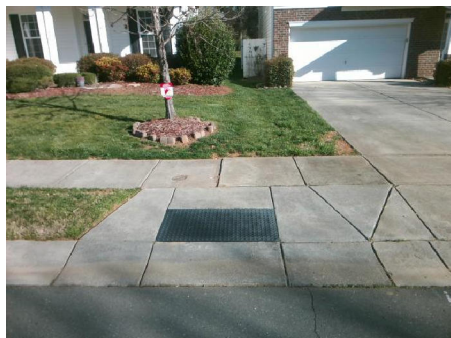
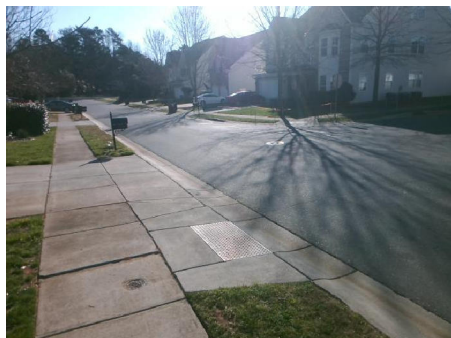
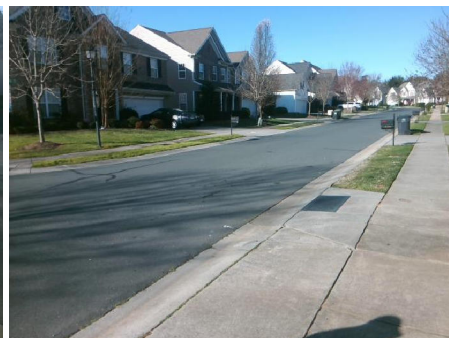
Possible Solutions:		Compliance	Description	Data	Compliance	Description	Data
	Remove & Replace Entire Ramp.		N/A	Ramp Length (in)	47.3	No	Ramp Slope (%)	9.7
			No	Ramp Width (in)	47.5	Yes	Ramp XSlope (%)	1.9
			N/A	Flare Type LT	N/A	N/A	Flare Type RT	N/A
			N/A	Flare Slope LT (%)	N/A	N/A	Flare Slope RT (%)	N/A
			N/A	Flare Traversable LT?	N/A	N/A	Flare Traversable RT?	N/A
			N/A	Landing Length (in)	N/A	N/A	DWS Provided?	N/A
			N/A	Landing Width (in)	N/A	N/A	DWS Contrast?	N/A
			N/A	Landing Slope (%)	N/A	N/A	DWS Length (in)	N/A
			N/A	Landing X Slope (%)	N/A	N/A	DWS Full Width?	N/A
<p>Surveyor Notes:</p> <p>N/A</p> <p>PROW/ADA:</p> <p>Not Found, R304.5.1, R304.2.2</p>			N/A	Landing Curb? (Y/N)	N/A	N/A	DWS Offset (in)	N/A
			N/A	Shared Landing?	N/A			
			N/A	Gutter Ponding?	N/A	N/A	Gutter Slope (%)	N/A
			N/A	Gutter Lip Ht (in)	N/A	N/A	Gutter X Slope (%)	N/A

N/A	Painted X Walk1?	No	N/A	Painted X Walk2?	N/A
				X Walk 1 Direction	To S		X Walk 2 Direction	N/A
			N/A	X Walk 1 Width (in)	N/A	N/A	X Walk 2 Width (in)	N/A
				X Walk 1 Slope (%)	1.7		X Walk 2 Slope (%)	N/A
				X Walk 1 X Slope (%)	2.3		X Walk 2 X Slope (%)	N/A
			N/A	Ramp inside XWalk1?	N/A	N/A	Ramp inside XWalk2?	N/A
<p>Street 1 Name</p> <p>Stop Condition-Street 2</p> <p>Street 2 Name</p> <p>Stop Condition-Street 1</p>				Road Slope (%)	N/A	N/A	Clear Space?	N/A
				Road X Slope (%)	N/A	N/A	Clear Space to XWalk (in)	N/A
			N/A	Any Obstructions?	N/A	N/A	Storm Grate/Utility Hazard?	N/A
				Obstruction Type			Storm Grate/Utility Type	
						N/A		N/A
						Yes	Surface Condition? (G/P)	Good
Total Cost:		\$	1850.00
