# Access Compliance Report

## Public Rights-of-Way

### (Curb Ramps)

Intersection ID: 42805	Main Street: CALDWELL_CROSSING_PY	Cross Street: SIDNEY_CREST_AV	Location: SW
ADA ID: 0A8B10453205	Ramp Type: PerpDiag	Initial Pass/Fail: Fail	Overall Compliance: No
Severity Score: 22.5			
Codes/Mitigation Info/Possible Solution		Field Measurements/Component Compliance

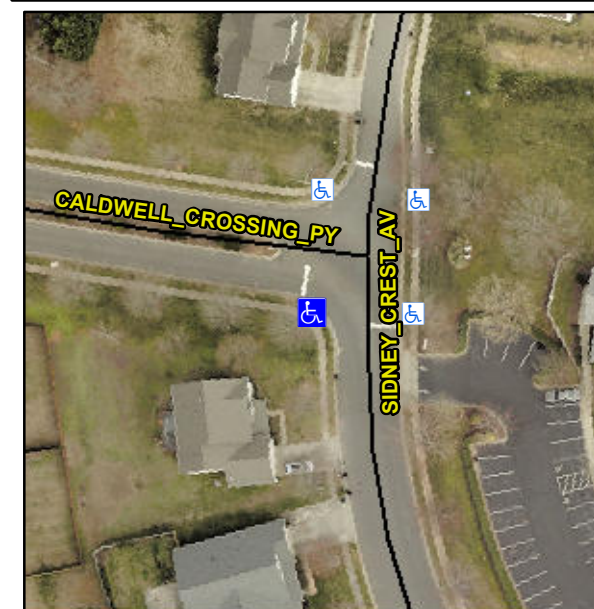
**Not Found, R304.5.1, R304.2.2, R304.5.3**

Compliance	Description	Data	Compliance	Description	Data
N/A	Ramp Length (in)	48.0	No	Ramp Slope (%)	11.4
No	Ramp Width (in)	42.0	No	Ramp XSlope (%)	3.7
N/A	Flare Type LT	N/A	N/A	Flare Type RT	N/A
N/A	Flare Slope LT (%)	N/A	N/A	Flare Slope RT (%)	N/A
N/A	Flare Traversable LT?	N/A	N/A	Flare Traversable RT?	N/A
N/A	Landing Length (in)	N/A	N/A	DWS Provided?	N/A
N/A	Landing Width (in)	N/A	N/A	DWS Contrast?	N/A
N/A	Landing Slope (%)	N/A	N/A	DWS Length (in)	N/A
N/A	Landing X Slope (%)	N/A	N/A	DWS Full Width?	N/A
N/A	Landing Curb? (Y/N)	N/A	N/A	DWS Offset (in)	N/A
N/A	Shared Landing?	N/A			
N/A	Gutter Ponding?	N/A	N/A	Gutter Slope (%)	N/A
N/A	Gutter Lip Ht (in)	N/A	N/A	Gutter X Slope (%)	N/A
N/A	Painted X Walk1?	No	N/A	Painted X Walk2?	No
	X Walk 1 Direction	To E		X Walk 2 Direction	To N
N/A	X Walk 1 Width (in)	N/A	N/A	X Walk 2 Width (in)	N/A
	X Walk 1 Slope (%)	5.5		X Walk 2 Slope (%)	1.5
	X Walk 1 X Slope (%)	0.2		X Walk 2 X Slope (%)	6.8

N/A	Ramp inside XWalk1?	N/A	N/A	Ramp inside XWalk2?	N/A
	Road Slope (%)	4.3	N/A	Clear Space?	N/A
	Road X Slope (%)	4.2	N/A	Clear Space to XWalk (in)	N/A
N/A	Any Obstructions?	N/A	N/A	Storm Grate/Utility Hazard?	N/A
	Obstruction Type			Storm Grate/Utility Type	
		N/A			N/A
			Yes	Surface Condition? (G/P)	Good

Possible Solutions:

**Remove & Replace Curb Ramp With Two New Directional Ramps or Equivalent.**
