Access Compliance Report

Public Rights-of-Way

(Curb Ramps)

Intersection ID: 46303	Main Street: HONEY_CREEK_LN	Cross Street: MERMANS_RD	Location:	NE
ADA ID: 0A9D48947FAD	Ramp Type: PerpDiag	Initial Pass/Fail: Fail	Overall Compliance: No	Severity Score: 10
Codes/Mitigation Info/Possible Solution		Field Measurements/Component Compliance

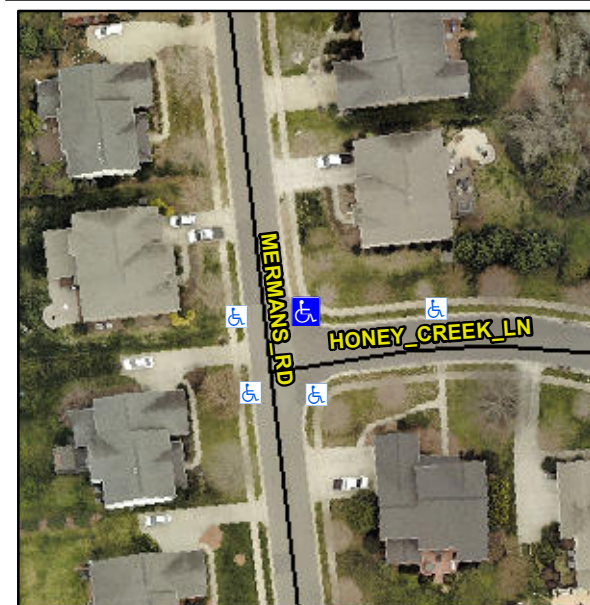
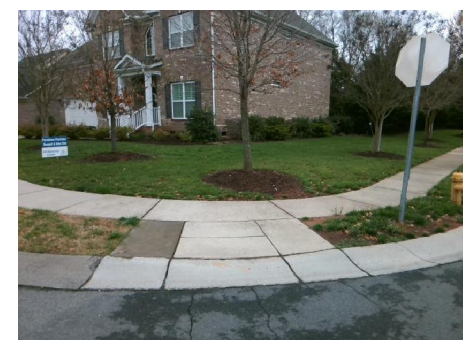
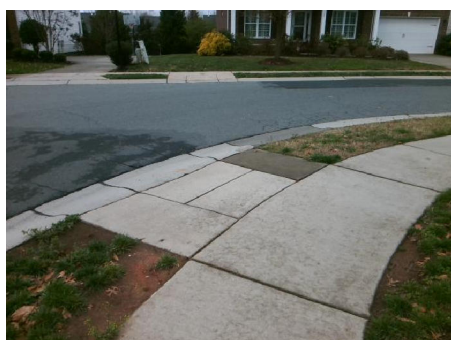
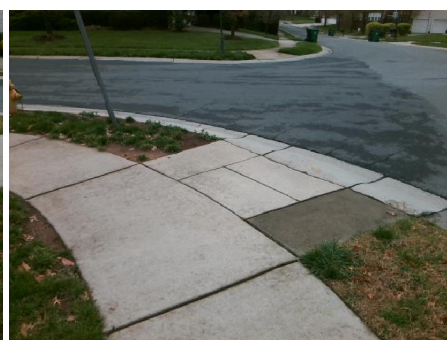
Not Found, R304.5.1, R304.5.3

Compliance	Description	Data	Compliance	Description	Data
N/A	Ramp Length (in)	48.0	Yes	Ramp Slope (%)	5.4
No	Ramp Width (in)	40.0	No	Ramp XSlope (%)	3.1
N/A	Flare Type LT	N/A	N/A	Flare Type RT	N/A
N/A	Flare Slope LT (%)	N/A	N/A	Flare Slope RT (%)	N/A
N/A	Flare Traversable LT?	N/A	N/A	Flare Traversable RT?	N/A
N/A	Landing Length (in)	N/A	N/A	DWS Provided?	N/A
N/A	Landing Width (in)	N/A	N/A	DWS Contrast?	N/A
N/A	Landing Slope (%)	N/A	N/A	DWS Length (in)	N/A
N/A	Landing X Slope (%)	N/A	N/A	DWS Full Width?	N/A
N/A	Landing Curb? (Y/N)	N/A	N/A	DWS Offset (in)	N/A
N/A	Shared Landing?	N/A			
N/A	Gutter Ponding?	N/A	N/A	Gutter Slope (%)	N/A
N/A	Gutter Lip Ht (in)	N/A	N/A	Gutter X Slope (%)	N/A
N/A	Painted X Walk1?	No	N/A	Painted X Walk2?	No
	X Walk 1 Direction	To W		X Walk 2 Direction	To S
N/A	X Walk 1 Width (in)	N/A	N/A	X Walk 2 Width (in)	N/A
	X Walk 1 Slope (%)	4.6		X Walk 2 Slope (%)	0.0
	X Walk 1 X Slope (%)	0.7		X Walk 2 X Slope (%)	3.7

N/A	Ramp inside XWalk1?	N/A	N/A	Ramp inside XWalk2?	N/A
	Road Slope (%)	1.9	N/A	Clear Space?	N/A
	Road X Slope (%)	1.5	N/A	Clear Space to XWalk (in)	N/A
N/A	Any Obstructions?	N/A	N/A	Storm Grate/Utility Hazard?	N/A
	Obstruction Type			Storm Grate/Utility Type	
		N/A			N/A
		Yes		Surface Condition? (G/P)	Good

Possible Solutions:

Remove & Replace Curb Ramp With Two New Directional Ramps or Equivalent.
