Access Compliance Report

Public Rights-of-Way (Curb Ramps)

Intersection ID: 10037245	Main Street: SARDIS_CROSSING_DR	Cross Street: N/A	Location: NE
ADA ID: 0AA1BCDF5FEF	Ramp Type: Perp	Initial Pass/Fail: Fail	Overall Compliance: No
Severity Score: 33.75			
Codes/Mitigation Info/Possible Solution		Field Measurements/Component Compliance

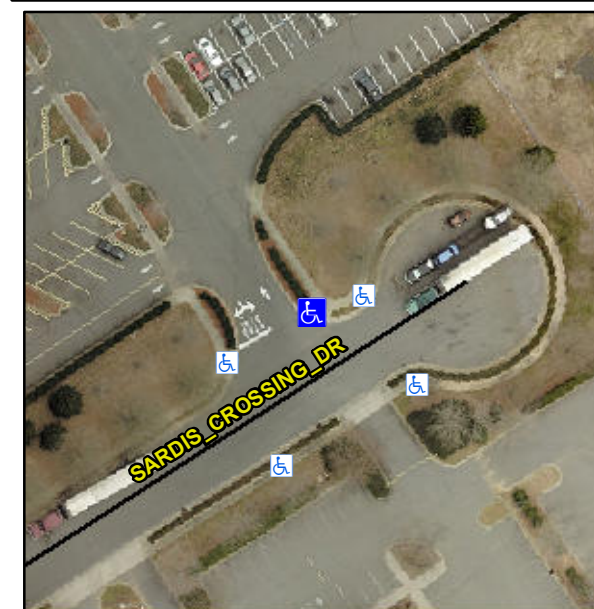
R304.5.1, R304.2.2, R304.5.3

Compliance	Description	Data	Compliance	Description	Data
N/A	Ramp Length (in)	73.0	No	Ramp Slope (%)	9.8
No	Ramp Width (in)	38.0	No	Ramp XSlope (%)	5.8
N/A	Flare Type LT	N/A	N/A	Flare Type RT	N/A
N/A	Flare Slope LT (%)	N/A	N/A	Flare Slope RT (%)	N/A
N/A	Flare Traversable LT?	N/A	N/A	Flare Traversable RT?	N/A
N/A	Landing Length (in)	N/A	N/A	DWS Provided?	N/A
N/A	Landing Width (in)	N/A	N/A	DWS Contrast?	N/A
N/A	Landing Slope (%)	N/A	N/A	DWS Length (in)	N/A
N/A	Landing X Slope (%)	N/A	N/A	DWS Full Width?	N/A
N/A	Landing Curb? (Y/N)	N/A	N/A	DWS Offset (in)	N/A
N/A	Shared Landing?	N/A			
N/A	Gutter Ponding?	N/A	N/A	Gutter Slope (%)	N/A
N/A	Gutter Lip Ht (in)	N/A	N/A	Gutter X Slope (%)	N/A
N/A	Painted X Walk1?	No	N/A	Painted X Walk2?	N/A
	X Walk 1 Direction	To SW		X Walk 2 Direction	N/A
N/A	X Walk 1 Width (in)	N/A	N/A	X Walk 2 Width (in)	N/A
	X Walk 1 Slope (%)	4.4		X Walk 2 Slope (%)	N/A
	X Walk 1 X Slope (%)	4.0		X Walk 2 X Slope (%)	N/A

Remove & Replace Entire Ramp.
