# Access Compliance Report

## Public Rights-of-Way

### (Curb Ramps)

Intersection ID: N/A	Main Street: N_SHARON_AMITY_RD	Cross Street: DELANE_AV	Location: NE
ADA ID: 0AC0A2944099	Ramp Type: Perp	Initial Pass/Fail: Fail	Overall Compliance: No
Severity Score: 12.5			
Codes/Mitigation Info/Possible Solution		Field Measurements/Component Compliance

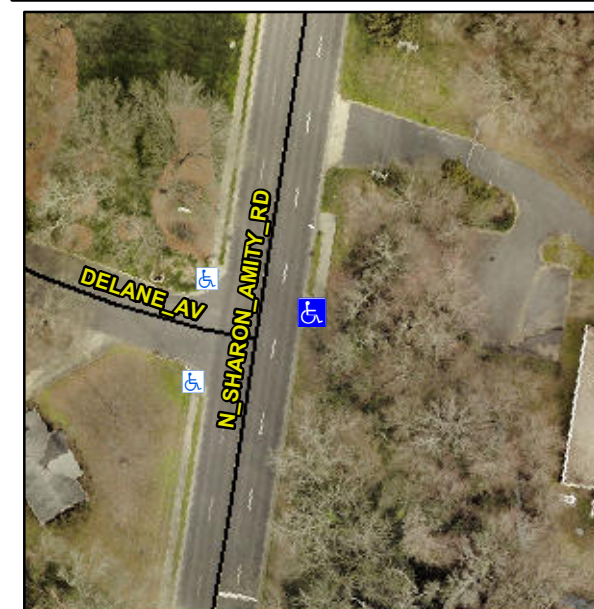
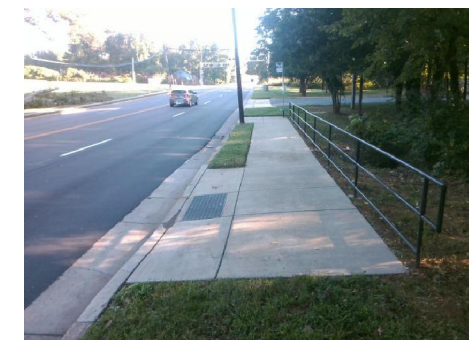
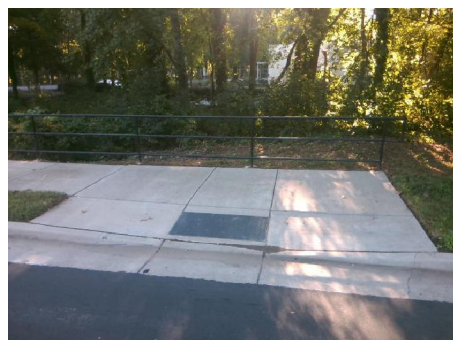
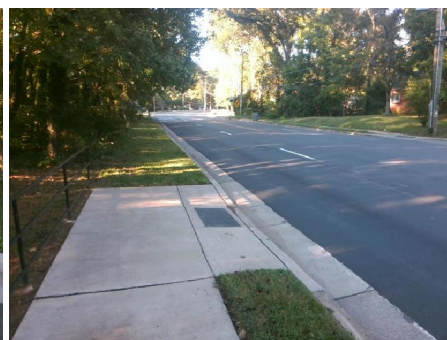
Compliance	Description	Data	Compliance	Description	Data
N/A	Ramp Length (in)	36.0	No	Ramp Slope (%)	8.8
Yes	Ramp Width (in)	48.0	Yes	Ramp XSlope (%)	0.3
N/A	Flare Type LT	N/A	N/A	Flare Type RT	N/A
N/A	Flare Slope LT (%)	N/A	N/A	Flare Slope RT (%)	N/A
N/A	Flare Traversable LT?	N/A	N/A	Flare Traversable RT?	N/A
N/A	Landing Length (in)	N/A	N/A	DWS Provided?	N/A
N/A	Landing Width (in)	N/A	N/A	DWS Contrast?	N/A
N/A	Landing Slope (%)	N/A	N/A	DWS Length (in)	N/A
N/A	Landing X Slope (%)	N/A	N/A	DWS Full Width?	N/A
N/A	Landing Curb? (Y/N)	N/A	N/A	DWS Offset (in)	N/A
N/A	Shared Landing?	N/A			
N/A	Gutter Ponding?	N/A	N/A	Gutter Slope (%)	N/A
N/A	Gutter Lip Ht (in)	N/A	N/A	Gutter X Slope (%)	N/A
N/A	Painted X Walk1?	No	N/A	Painted X Walk2?	N/A
	X Walk 1 Direction	To NW		X Walk 2 Direction	N/A
N/A	X Walk 1 Width (in)	N/A	N/A	X Walk 2 Width (in)	N/A
	X Walk 1 Slope (%)	7.3		X Walk 2 Slope (%)	N/A
	X Walk 1 X Slope (%)	0.9		X Walk 2 X Slope (%)	N/A

N/A	Ramp inside XWalk1?	N/A	N/A	Ramp inside XWalk2?	N/A
	Road Slope (%)	N/A	N/A	Clear Space?	N/A
	Road X Slope (%)	N/A	N/A	Clear Space to XWalk (in)	N/A
N/A	Any Obstructions?	N/A	N/A	Storm Grate/Utility Hazard?	N/A
	Obstruction Type			Storm Grate/Utility Type	
		N/A			N/A
		Yes		Surface Condition? (G/P)	Good

Possible Solutions:

**Remove & Replace Entire Ramp.**

**R304.2.2**

**\$ 1850.00**
