# Access Compliance Report

## Public Rights-of-Way

| Intersection ID: 52718 | Main Street: AGAVA_LN | Cross Street: MAIDENHAIR_CT | Location: W |
| ADA ID: 0AC38D1DD7FF | Ramp Type: Perp | Initial Pass/Fail: Pass | Overall Compliance: No |

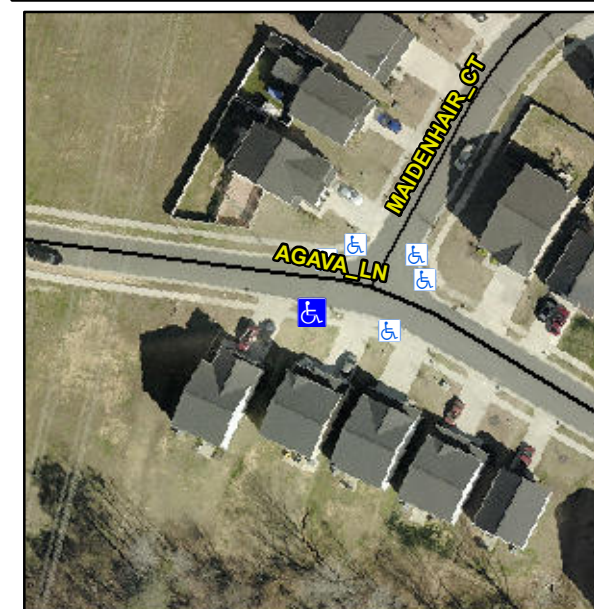
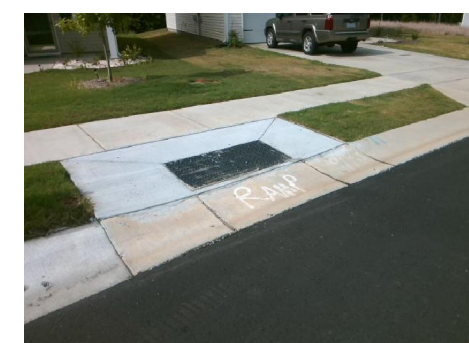
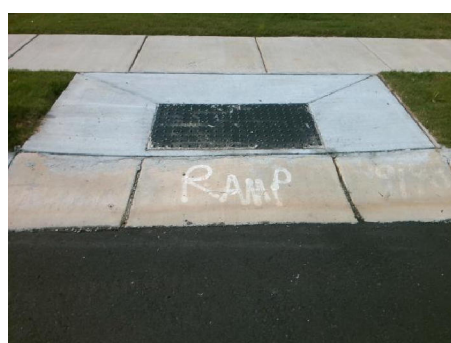
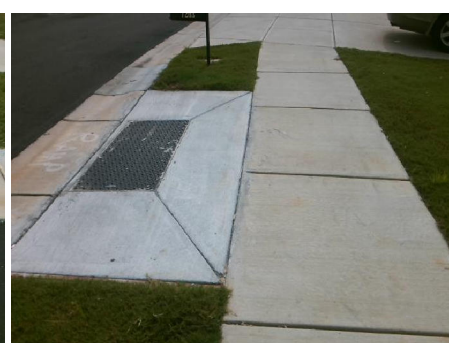
**Not Found, R304.2.1, R305.2,  
R304.5.4**

| Compliance | Description | Data | Compliance | Description | Data |
|---|---|---|---|---|---|
| No | Landing Length (in) | 47.0 | Yes | DWS Provided? | Yes |
| N/A | Landing Curb? (Y/N) | No | No | DWS Offset (in) | 2.5 |
| Yes | Gutter Ponding? | No | No | Gutter Slope (%) | 10.4 |

**Remove & Replace Entire Ramp.  
Remove & Replace Gutter.**
