Access Compliance Report

Public Rights-of-Way

(Curb Ramps)

Intersection ID: 53713	Main Street: N_TRYON_ST	Cross Street: PERIWINKLE_HILL_AV	Location: NW
ADA ID: 0AD3EF11745A	Ramp Type: Perp	Initial Pass/Fail: Fail	Overall Compliance: No
Codes/Mitigation Info/Possible Solution		Field Measurements/Component Compliance	
Severity Score: 8.75

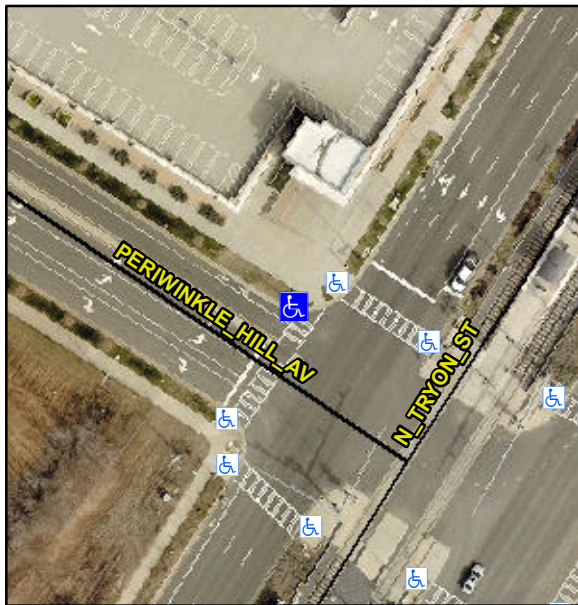
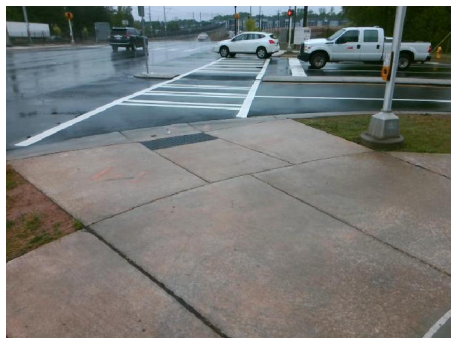
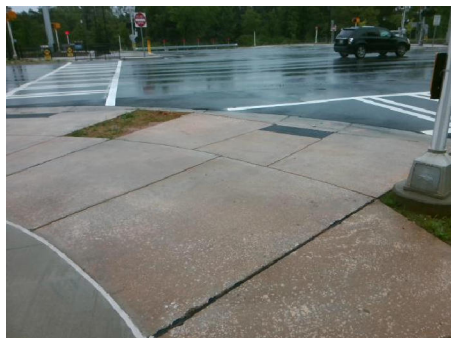
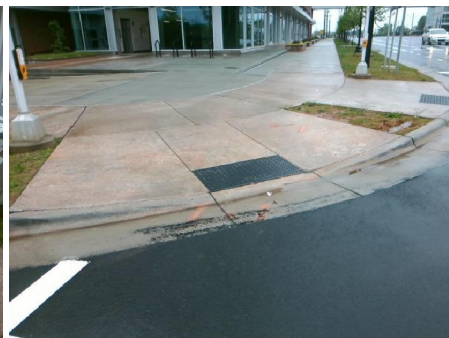
Not Found, R304.5.1

Compliance	Description	Data	Compliance	Description	Data
N/A	Ramp Length (in)	95.0	Yes	Ramp Slope (%)	5.3
No	Ramp Width (in)	47.0	Yes	Ramp XSlope (%)	0.2
N/A	Flare Type LT	N/A	N/A	Flare Type RT	N/A
N/A	Flare Slope LT (%)	N/A	N/A	Flare Slope RT (%)	N/A
N/A	Flare Traversable LT?	N/A	N/A	Flare Traversable RT?	N/A
N/A	Landing Length (in)	N/A	N/A	DWS Provided?	N/A
N/A	Landing Width (in)	N/A	N/A	DWS Contrast?	N/A
N/A	Landing Slope (%)	N/A	N/A	DWS Length (in)	N/A
N/A	Landing X Slope (%)	N/A	N/A	DWS Full Width?	N/A
N/A	Landing Curb? (Y/N)	N/A	N/A	DWS Offset (in)	N/A
N/A	Shared Landing?	N/A			
N/A	Gutter Ponding?	N/A	N/A	Gutter Slope (%)	N/A
N/A	Gutter Lip Ht (in)	N/A	N/A	Gutter X Slope (%)	N/A
N/A	Painted X Walk1?	Yes	N/A	Painted X Walk2?	N/A
	X Walk 1 Direction	To SW		X Walk 2 Direction	N/A
N/A	X Walk 1 Width (in)	117.0	N/A	X Walk 2 Width (in)	N/A
	X Walk 1 Slope (%)	1.7		X Walk 2 Slope (%)	N/A
	X Walk 1 X Slope (%)	2.8		X Walk 2 X Slope (%)	N/A

N/A	Ramp inside XWalk1?	Yes	N/A	Ramp inside XWalk2?	N/A
	Road Slope (%)	N/A	N/A	Clear Space?	N/A
	Road X Slope (%)	N/A	N/A	Clear Space to XWalk (in)	N/A
N/A	Any Obstructions?	N/A	N/A	Storm Grate/Utility Hazard?	N/A
	Obstruction Type			Storm Grate/Utility Type	
		N/A			N/A
		Yes		Surface Condition? (G/P)	Good

Remove & Replace Entire Ramp.
