# Access Compliance Report

## Public Rights-of-Way

### (Curb Ramps)

Intersection ID: 47646	Main Street: ALDWYCH_WY	Cross Street: DESHLER_MORRIS_LN	Location:	N
ADA ID: 0AD65F56E2FC	Ramp Type: PerpDiag	Initial Pass/Fail: Fail	Overall Compliance: No	Severity Score: 13.75
Codes/Mitigation Info/Possible Solution		Field Measurements/Component Compliance

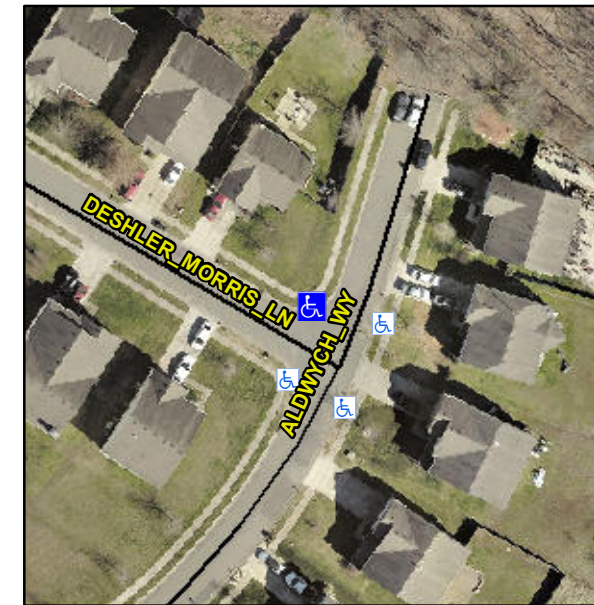
**Not Found, R304.2.2, R304.5.3**

Compliance	Description	Data	Compliance	Description	Data
N/A	Ramp Length (in)	48.0	No	Ramp Slope (%)	8.7
Yes	Ramp Width (in)	48.0	No	Ramp XSlope (%)	3.3
N/A	Flare Type LT	N/A	N/A	Flare Type RT	N/A
N/A	Flare Slope LT (%)	N/A	N/A	Flare Slope RT (%)	N/A
N/A	Flare Traversable LT?	N/A	N/A	Flare Traversable RT?	N/A
N/A	Landing Length (in)	N/A	N/A	DWS Provided?	N/A
N/A	Landing Width (in)	N/A	N/A	DWS Contrast?	N/A
N/A	Landing Slope (%)	N/A	N/A	DWS Length (in)	N/A
N/A	Landing X Slope (%)	N/A	N/A	DWS Full Width?	N/A
N/A	Landing Curb? (Y/N)	N/A	N/A	DWS Offset (in)	N/A
N/A	Shared Landing?	N/A			
N/A	Gutter Ponding?	N/A	N/A	Gutter Slope (%)	N/A
N/A	Gutter Lip Ht (in)	N/A	N/A	Gutter X Slope (%)	N/A
N/A	Painted X Walk1?	No	N/A	Painted X Walk2?	No
	X Walk 1 Direction	To SW		X Walk 2 Direction	To SE
N/A	X Walk 1 Width (in)	N/A	N/A	X Walk 2 Width (in)	N/A
	X Walk 1 Slope (%)	3.6		X Walk 2 Slope (%)	4.4
	X Walk 1 X Slope (%)	1.3		X Walk 2 X Slope (%)	3.9

N/A	Ramp inside XWalk1?	N/A	N/A	Ramp inside XWalk2?	N/A
	Road Slope (%)	3.9	N/A	Clear Space?	N/A
	Road X Slope (%)	2.2	N/A	Clear Space to XWalk (in)	N/A
N/A	Any Obstructions?	N/A	N/A	Storm Grate/Utility Hazard?	N/A
	Obstruction Type			Storm Grate/Utility Type	
		N/A			N/A
			Yes	Surface Condition? (G/P)	Good

**Remove & Replace Curb Ramp With Two New Directional Ramps or Equivalent.**

Total Cost: \$ 3200.00
