Access Compliance Report

Public Rights-of-Way

(Curb Ramps)

Intersection ID: N/A	Main Street: PROVIDENCE_RD	Cross Street: N/A	Location: SE
ADA ID: 0AD7AFC36AE6	Ramp Type: BlendTrans2	Initial Pass/Fail: Fail	Overall Compliance: No
		Severity Score: 1.25

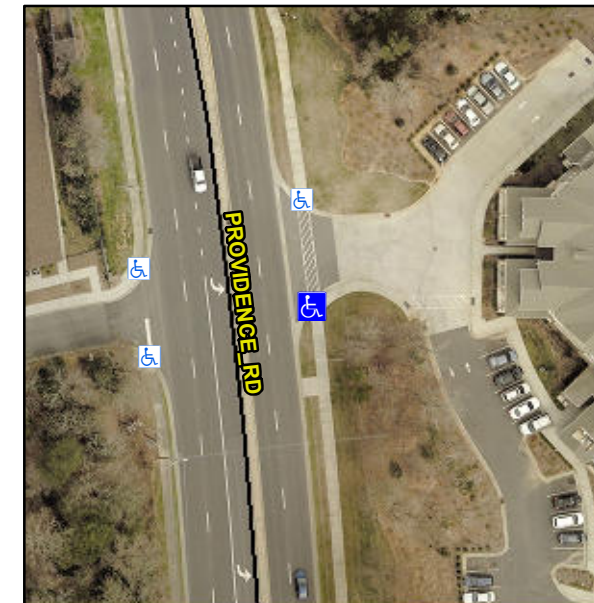
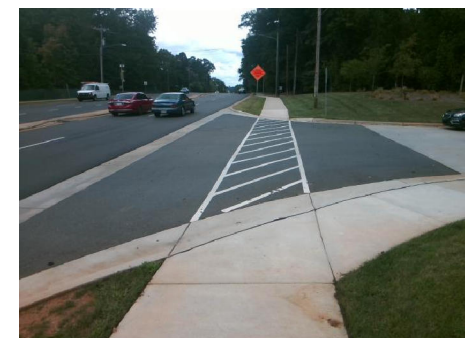
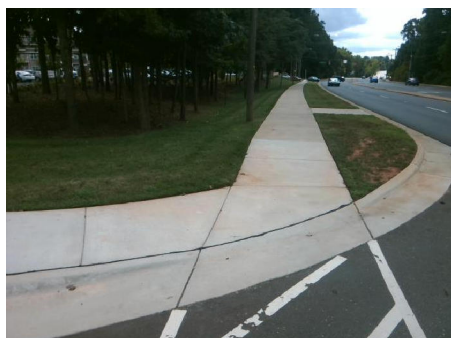
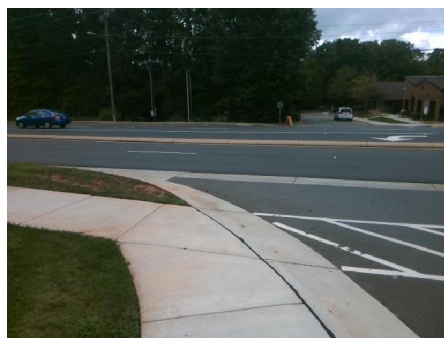
Compliance	Description	Data	Compliance	Description	Data
N/A	Ramp Length (in)	63.5	Yes	BlendTrans Slope (%)	1.3
Yes	Ramp Width (in)	48.0	No	BlendTrans XSlope (%)	2.3
N/A	Flare Type LT	N/A	N/A	Flare Type RT	N/A
N/A	Flare Slope LT (%)	N/A	N/A	Flare Slope RT (%)	N/A
N/A	Flare Traversable LT?	N/A	N/A	Flare Traversable RT?	N/A
N/A	Landing Length (in)	N/A	N/A	DWS Provided?	N/A
N/A	Landing Width (in)	N/A	N/A	DWS Contrast?	N/A
N/A	Landing Slope (%)	N/A	N/A	DWS Length (in)	N/A
N/A	Landing X Slope (%)	N/A	N/A	DWS Full Width?	N/A
N/A	Landing Curb? (Y/N)	N/A	N/A	DWS Offset (in)	N/A
N/A	Shared Landing?	N/A			
N/A	Gutter Ponding?	N/A	N/A	Gutter Slope (%)	N/A
N/A	Gutter Lip Ht (in)	N/A	N/A	Gutter X Slope (%)	N/A
N/A	Painted X Walk1?	Yes	N/A	Painted X Walk2?	N/A
	X Walk 1 Direction	To N		X Walk 2 Direction	N/A
	X Walk 1 Width (in)	66.0		X Walk 2 Width (in)	N/A
	X Walk 1 Slope (%)	1.9		X Walk 2 Slope (%)	N/A
	X Walk 1 X Slope (%)	2.5		X Walk 2 X Slope (%)	N/A

N/A	Ramp inside XWalk1?	Yes	N/A	Ramp inside XWalk2?	N/A
	Road Slope (%)	2.5		Clear Space?	N/A
	Road X Slope (%)	1.9	N/A	Clear Space to XWalk (in)	N/A
N/A	Any Obstructions?	N/A	N/A	Storm Grate/Utility Hazard?	N/A
	Obstruction Type			Storm Grate/Utility Type	
		N/A			N/A
			Yes	Surface Condition? (G/P)	Good
			N/A	Curb Slope (%)	4.4

Possible Solutions:

Remove & Replace Curb Ramp With Two New Directional Ramps or Equivalent.

R304.5.3
