Access Compliance Report

Public Rights-of-Way

(Curb Ramps)

Intersection ID: N/A	Main Street: WINTERHAVEN_DR	Cross Street: N/A	Location: SE
ADA ID: 0AE163AAE72C	Ramp Type: PerpDiag	Initial Pass/Fail: Fail	Overall Compliance: No
Codes/Mitigation Info/Possible Solution		Field Measurements/Component Compliance

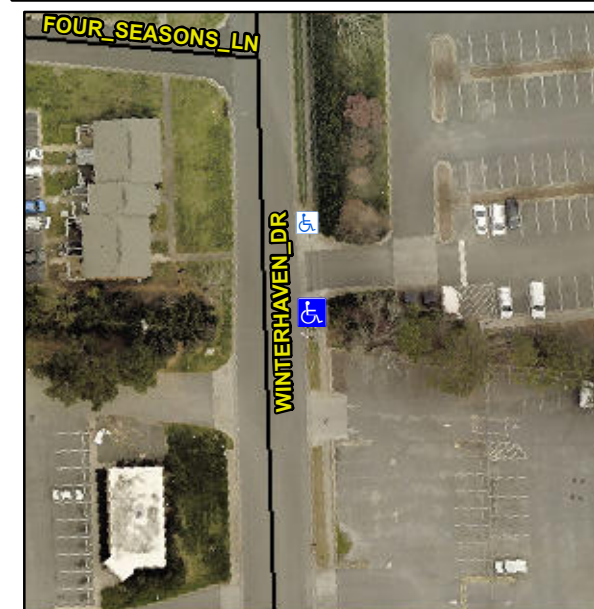
Not Found, R304.5.1, R304.5.3

Compliance	Description	Data	Compliance	Description	Data
N/A	Ramp Length (in)	29.0	Yes	Ramp Slope (%)	5.9
No	Ramp Width (in)	42.0	No	Ramp XSlope (%)	17.9
N/A	Flare Type LT	N/A	N/A	Flare Type RT	N/A
N/A	Flare Slope LT (%)	N/A	N/A	Flare Slope RT (%)	N/A
N/A	Flare Traversable LT?	N/A	N/A	Flare Traversable RT?	N/A
N/A	Landing Length (in)	N/A	N/A	DWS Provided?	N/A
N/A	Landing Width (in)	N/A	N/A	DWS Contrast?	N/A
N/A	Landing Slope (%)	N/A	N/A	DWS Length (in)	N/A
N/A	Landing X Slope (%)	N/A	N/A	DWS Full Width?	N/A
N/A	Landing Curb? (Y/N)	N/A	N/A	DWS Offset (in)	N/A
N/A	Shared Landing?	N/A			
N/A	Gutter Ponding?	N/A	N/A	Gutter Slope (%)	N/A
N/A	Gutter Lip Ht (in)	N/A	N/A	Gutter X Slope (%)	N/A
N/A	Painted X Walk1?	No	N/A	Painted X Walk2?	No
	X Walk 1 Direction	To N		X Walk 2 Direction	To W
N/A	X Walk 1 Width (in)	N/A	N/A	X Walk 2 Width (in)	N/A
	X Walk 1 Slope (%)	3.6		X Walk 2 Slope (%)	2.1
	X Walk 1 X Slope (%)	12.5		X Walk 2 X Slope (%)	6.0

N/A	Ramp inside XWalk1?	N/A	N/A	Ramp inside XWalk2?	N/A
	Road Slope (%)	14.5	N/A	Clear Space?	N/A
	Road X Slope (%)	0.2	N/A	Clear Space to XWalk (in)	N/A
N/A	Any Obstructions?	N/A	N/A	Storm Grate/Utility Hazard?	N/A
	Obstruction Type			Storm Grate/Utility Type	
		N/A			N/A
		Yes		Surface Condition? (G/P)	Good

Possible Solutions:

Remove & Replace Curb Ramp With Two New Directional Ramps or Equivalent.
