# Access Compliance Report

## Public Rights-of-Way

### (Curb Ramps)

Intersection ID: 29984	Main Street: CORBETT_SQUARE_LN	Cross Street: OLD_CAROLINA_DR	Location: SE
ADA ID: 0AE50C6597E1	Ramp Type: PerpDiag	Initial Pass/Fail: Fail	Overall Compliance: No
Codes/Mitigation Info/Possible Solution		Field Measurements/Component Compliance	
Severity Score: 46.25

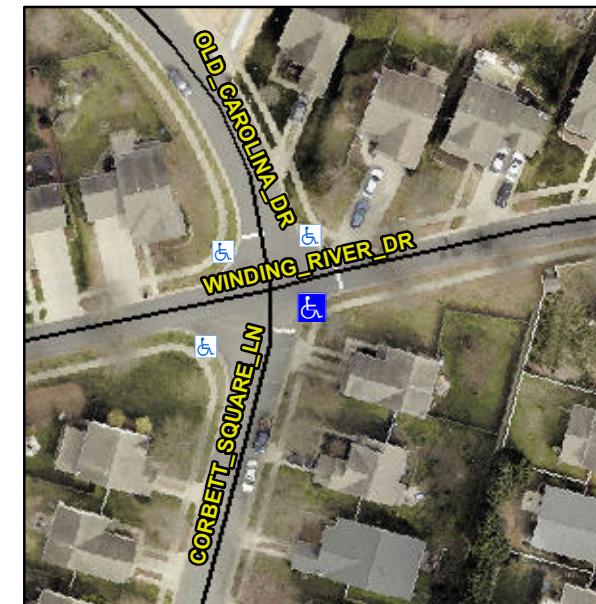
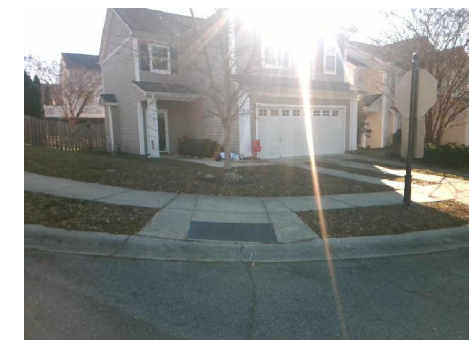
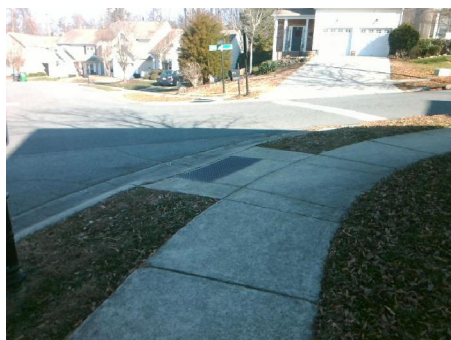
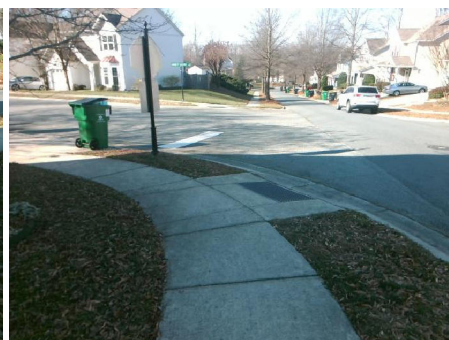
**Not Found, R304.5.1, R304.2.2, R304.5.3**

Compliance	Description	Data	Compliance	Description	Data
N/A	Ramp Length (in)	46.0	No	Ramp Slope (%)	11.7
No	Ramp Width (in)	47.0	No	Ramp XSlope (%)	10.2
N/A	Flare Type LT	N/A	N/A	Flare Type RT	N/A
N/A	Flare Slope LT (%)	N/A	N/A	Flare Slope RT (%)	N/A
N/A	Flare Traversable LT?	N/A	N/A	Flare Traversable RT?	N/A
N/A	Landing Length (in)	N/A	N/A	DWS Provided?	N/A
N/A	Landing Width (in)	N/A	N/A	DWS Contrast?	N/A
N/A	Landing Slope (%)	N/A	N/A	DWS Length (in)	N/A
N/A	Landing X Slope (%)	N/A	N/A	DWS Full Width?	N/A
N/A	Landing Curb? (Y/N)	N/A	N/A	DWS Offset (in)	N/A
N/A	Shared Landing?	N/A			
N/A	Gutter Ponding?	N/A	N/A	Gutter Slope (%)	N/A
N/A	Gutter Lip Ht (in)	N/A	N/A	Gutter X Slope (%)	N/A
N/A	Painted X Walk1?	No	N/A	Painted X Walk2?	No
	X Walk 1 Direction	To N		X Walk 2 Direction	To W
N/A	X Walk 1 Width (in)	N/A	N/A	X Walk 2 Width (in)	N/A
	X Walk 1 Slope (%)	2.9		X Walk 2 Slope (%)	8.0
	X Walk 1 X Slope (%)	6.0		X Walk 2 X Slope (%)	0.9

N/A	Ramp inside XWalk1?	N/A	N/A	Ramp inside XWalk2?	N/A
	Road Slope (%)	6.6	N/A	Clear Space?	N/A
	Road X Slope (%)	3.9	N/A	Clear Space to XWalk (in)	N/A
N/A	Any Obstructions?	N/A	N/A	Storm Grate/Utility Hazard?	N/A
	Obstruction Type			Storm Grate/Utility Type	
		N/A			N/A
			Yes	Surface Condition? (G/P)	Good

**Remove & Replace Curb Ramp With Two New Directional Ramps or Equivalent.**

Total Cost: \$ 3200.00
