Access Compliance Report

Public Rights-of-Way

(Curb Ramps)

Intersection ID: N/A		Main Street: MONROE_RD		Cross Street: KNICKERBOCKER_DR		Location: NE											
ADA ID: 0AF39C6574B6		Ramp Type: Directional1		Initial Pass/Fail: Fail		Overall Compliance: No		Severity Score: 1.25									
Codes/Mitigation Info/Possible Solution				Field Measurements/Component Compliance													
<div>

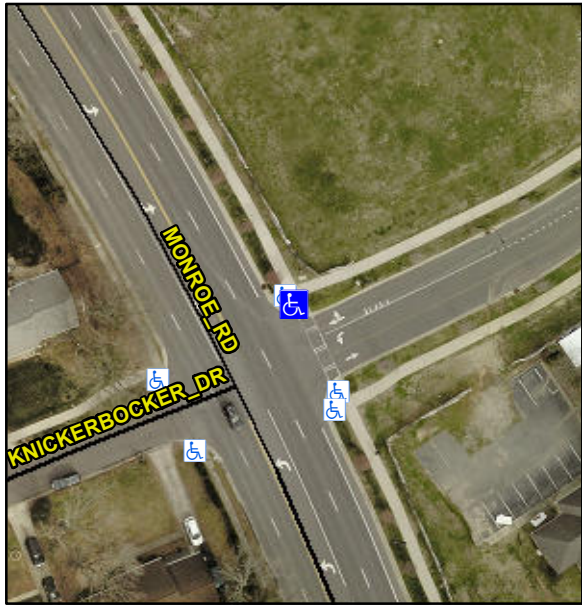
</div> <div>Possible Solutions:</div> <div>Remove & Replace Entire Ramp.</div> <div>Surveyor Notes:</div> <div>N/A</div> <div>PROW/ADA:</div> <div>R304.5.3</div> <div>Street 1 Name</div> <div>KNICKERBOCKER DR</div> <div>Stop Condition-Street 1</div> <div>StopSign</div> <div>Street 2 Name</div> <div>N/A</div> <div>Stop Condition-Street 2</div> <div>N/A</div> <div>Total Cost:</div> <div>\$</div> <div>1600.00</div>				Compliance		Description		Data		Compliance		Description		Data			
				N/A		Ramp Length (in)		81.0		N/A		Grade Break?		N/A		N/A	
				Yes		Ramp Width (in)		70.0		N/A		Grade Break Slope (%)		0.0		0.0

Yes		Ramp Slope (%)		7.8		N/A		Grade Break XSlope (%)		0.0		0.0	
				No		Ramp XSlope (%)		2.9									
				N/A		Flare Type LT		N/A		N/A		Flare Type RT		N/A		N/A	
				N/A		Flare Slope LT (%)		N/A		N/A		Flare Slope RT (%)		0.0		0.0	
				N/A		Flare Traversable LT?		N/A		N/A		Flare Traversable RT?		N/A		N/A	
				N/A		Landing Length (in)		0.0		N/A		DWS Provided?		N/A		N/A	
				N/A		Landing Width (in)		0.0		N/A		DWS Contrast?		N/A		N/A	
				N/A		Landing Slope (%)		0.0		N/A		DWS Length (in)		N/A		N/A	
				N/A		Landing X Slope (%)		0.0		N/A		DWS Full Width?		N/A		N/A	
				N/A		Landing Curb? (Y/N)		N/A		N/A		DWS Offset LT (in)		N/A		N/A	
				N/A		Shared Landing?		N/A		N/A		DWS Offset RT (in)		N/A		N/A	
				N/A		Gutter Ponding?		0.0		N/A		Gutter Slope (%)		N/A		N/A	
				N/A		Gutter Lip Ht (in)		0.0		N/A		Gutter X Slope (%)		N/A		N/A	
				N/A		Painted X Walk1?		Yes				Road Slope (%)		1.0		1.0	
						X Walk 1 Direction		To SE				Road X Slope (%)		0.0		0.0

X Walk 1 Width (in)		70.0				Clear Space?		N/A		N/A	
						X Walk 1 Slope (%)		1.0		N/A		Clear Space to XWalk (in)		N/A		N/A	
						X Walk 1 X Slope (%)		0.0		N/A		Storm Grate/Utility Hazard?		N/A		N/A	
				N/A		Ramp inside XWalk1?		Yes				Storm Grate/Utility Type					
				N/A		Any Obstructions?		N/A						N/A		N/A	
						Obstruction Type				Yes		Surface Condition? (G/P)		Good		Good	
										N/A		N/A		Curb Slope (%)		5.2
