Access Compliance Report Public Rights-of-Way (Curb Ramps)

Intersection ID: 10194 Main Street: BURTON ST **Cross Street: SPRING ST** Location: S **Overall Compliance: No Severity Score:** ADA ID: 0AF75080B9D7 Ramp Type: Combination2 Initial Pass/Fail: Fail 1.25

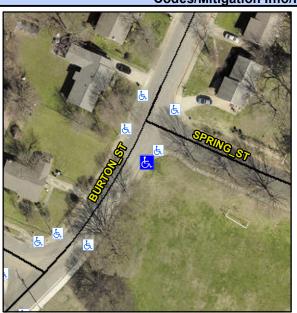
Possible Solutions: Compliance Description N/A Remove & Replace Entire Ramp. Yes Yes Yes N/A Yes Surveyor Notes: N/A **RT RP < 5%** N/A N/A N/A N/A PROW/ADA: N/A Not Found, R304.5.3 N/A N/A N/A N/A N/A
