Access Compliance Report

Public Rights-of-Way

(Curb Ramps)

Intersection ID: 11839	Main Street: FLEETWOOD_DR	Cross Street: EVERGREEN_DR	Location: SE
ADA ID: 0AFEAD039EAA	Ramp Type: Perp	Initial Pass/Fail: Fail	Overall Compliance: No
			Severity Score: 21.25

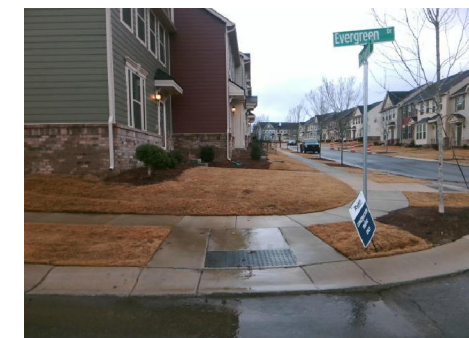
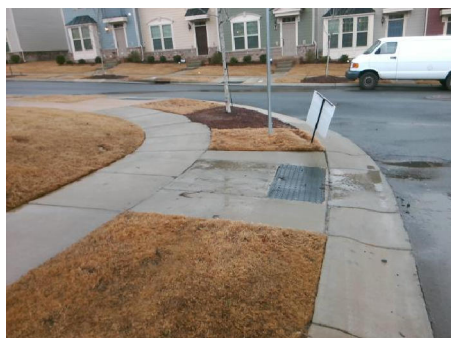
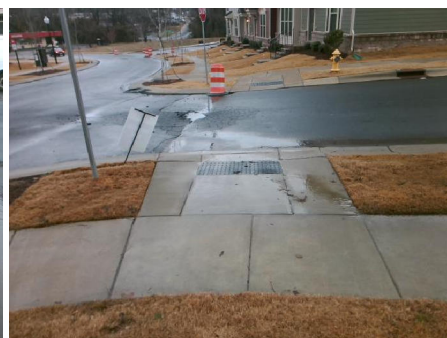
Not Found, R304.5.1, R304.2.2

Compliance	Description	Data	Compliance	Description	Data
N/A	Ramp Length (in)	73.0	No	Ramp Slope (%)	10.1
No	Ramp Width (in)	47.0	Yes	Ramp XSlope (%)	0.6
N/A	Flare Type LT	N/A	N/A	Flare Type RT	N/A
N/A	Flare Slope LT (%)	N/A	N/A	Flare Slope RT (%)	N/A
N/A	Flare Traversable LT?	N/A	N/A	Flare Traversable RT?	N/A
N/A	Landing Length (in)	N/A	N/A	DWS Provided?	N/A
N/A	Landing Width (in)	N/A	N/A	DWS Contrast?	N/A
N/A	Landing Slope (%)	N/A	N/A	DWS Length (in)	N/A
N/A	Landing X Slope (%)	N/A	N/A	DWS Full Width?	N/A
N/A	Landing Curb? (Y/N)	N/A	N/A	DWS Offset (in)	N/A
N/A	Shared Landing?	N/A			
N/A	Gutter Ponding?	N/A	N/A	Gutter Slope (%)	N/A
N/A	Gutter Lip Ht (in)	N/A	N/A	Gutter X Slope (%)	N/A
N/A	Painted X Walk1?	No	N/A	Painted X Walk2?	N/A
	X Walk 1 Direction	To N		X Walk 2 Direction	N/A
N/A	X Walk 1 Width (in)	N/A	N/A	X Walk 2 Width (in)	N/A
	X Walk 1 Slope (%)	2.5		X Walk 2 Slope (%)	N/A
	X Walk 1 X Slope (%)	1.9		X Walk 2 X Slope (%)	N/A

N/A	Ramp inside XWalk1?	N/A	N/A	Ramp inside XWalk2?	N/A
	Road Slope (%)	N/A	N/A	Clear Space?	N/A
	Road X Slope (%)	N/A	N/A	Clear Space to XWalk (in)	N/A
N/A	Any Obstructions?	N/A	N/A	Storm Grate/Utility Hazard?	N/A
	Obstruction Type			Storm Grate/Utility Type	
		N/A			N/A
			Yes	Surface Condition? (G/P)	Good

Remove & Replace Entire Ramp.

Total Cost: \$ 1850.00
