# Access Compliance Report

## Public Rights-of-Way

### (Curb Ramps)

Intersection ID: 10035419	Main Street: RANDOLPH_RD	Cross Street: N/A	Location: NW
ADA ID: 0B069638F877	Ramp Type: Perp	Initial Pass/Fail: Fail	Overall Compliance: No
Severity Score: 1.25			
Codes/Mitigation Info/Possible Solution		Field Measurements/Component Compliance

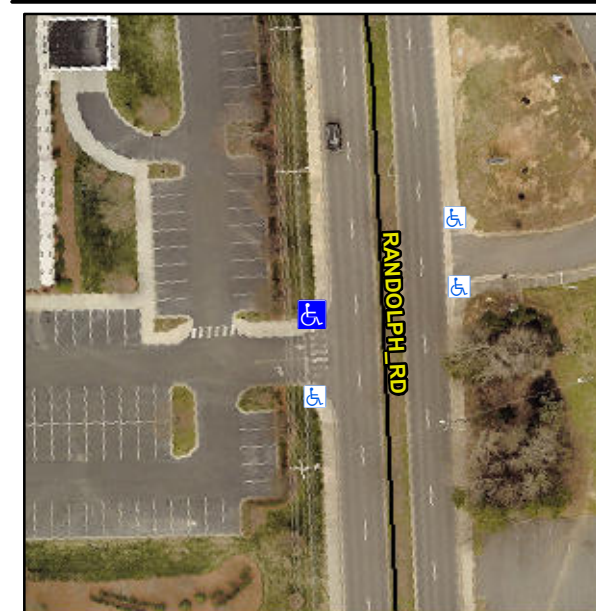
Compliance	Description	Data	Compliance	Description	Data
N/A	Ramp Length (in)	26.5	Yes	Ramp Slope (%)	7.4
Yes	Ramp Width (in)	48.0	No	Ramp XSlope (%)	2.1
N/A	Flare Type LT	N/A	N/A	Flare Type RT	N/A
N/A	Flare Slope LT (%)	N/A	N/A	Flare Slope RT (%)	N/A
N/A	Flare Traversable LT?	N/A	N/A	Flare Traversable RT?	N/A
N/A	Landing Length (in)	N/A	N/A	DWS Provided?	N/A
N/A	Landing Width (in)	N/A	N/A	DWS Contrast?	N/A
N/A	Landing Slope (%)	N/A	N/A	DWS Length (in)	N/A
N/A	Landing X Slope (%)	N/A	N/A	DWS Full Width?	N/A
N/A	Landing Curb? (Y/N)	N/A	N/A	DWS Offset (in)	N/A
N/A	Shared Landing?	N/A			
N/A	Gutter Ponding?	N/A	N/A	Gutter Slope (%)	N/A
N/A	Gutter Lip Ht (in)	N/A	N/A	Gutter X Slope (%)	N/A
N/A	Painted X Walk1?	Yes	N/A	Painted X Walk2?	N/A
	X Walk 1 Direction	To S		X Walk 2 Direction	N/A
N/A	X Walk 1 Width (in)	90.0	N/A	X Walk 2 Width (in)	N/A
	X Walk 1 Slope (%)	3.1		X Walk 2 Slope (%)	N/A
	X Walk 1 X Slope (%)	1.2		X Walk 2 X Slope (%)	N/A

N/A	Ramp inside XWalk1?	Yes	N/A	Ramp inside XWalk2?	N/A
	Road Slope (%)	N/A	N/A	Clear Space?	N/A
	Road X Slope (%)	N/A	N/A	Clear Space to XWalk (in)	N/A
N/A	Any Obstructions?	N/A	N/A	Storm Grate/Utility Hazard?	N/A
	Obstruction Type			Storm Grate/Utility Type	
		N/A			N/A
		Yes		Surface Condition? (G/P)	Good

Possible Solutions:

**Remove & Replace Entire Ramp.**

**Not Found, R304.5.3**

Total Cost: \$ 1850.00
