## **Access Compliance Report Public Rights-of-Way** (Curb Ramps)

Intersection ID: 2616 Main Street: CAMBELLTON DR Cross Street: HIGHLAND\_CREEK\_PY Location: **ADA ID: 0B0EA5ED6496** Ramp Type: Perp Initial Pass/Fail: Fail **Overall Compliance: No** Severity Score: 33.75

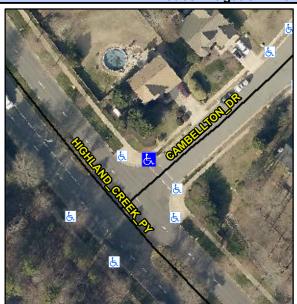
Field Measurements/Component Compliance						
Compl	iance Description	Data	Compl	iance	Description	Data
N/A	Ramp Length (in)	54.0	No	Ramp	Slope (%)	9.8
No	Ramp Width (in)	41.0	No	Ramp	XSlope (%)	6.9
N/A	Flare Type LT	N/A	N/A	Flare	Type RT	N/A
N/A	Flare Slope LT (%)	N/A	N/A	Flare	Slope RT (%)	N/A
N/A	Flare Traversable LT?	N/A	N/A	Flare	Traversable RT?	N/A
N/A	Landing Length (in)	N/A	N/A	DWS	Provided?	N/A
N/A	Landing Width (in)	N/A	N/A	DWS	Contrast?	N/A
N/A	Landing Slope (%)	N/A	N/A	DWS	Length (in)	N/A
N/A	Landing X Slope (%)	N/A	N/A	DWS	Full Width?	N/A
N/A	Landing Curb? (Y/N)	N/A	N/A	DWS	Offset (in)	N/A
N/A	Shared Landing?	N/A				
N/A	Gutter Ponding?	N/A	N/A	Gutte	er Slope (%)	N/A
N/A	Gutter Lip Ht (in)	N/A	N/A	Gutte	r X Slope (%)	N/A
N/A	Painted X Walk1?	Yes	N/A	Paint	ed X Walk2?	N/A
	X Walk 1 Direction	To SE		X Wa	lk 2 Direction	N/A
N/A	X Walk 1 Width (in)	93.0	N/A	X Wa	lk 2 Width (in)	N/A
	X Walk 1 Slope (%)	4.3		X Wa	lk 2 Slope (%)	N/A

X Walk 1 X Slope (%)	3.7		X Wa	lk 2 X Slope (%)	N/A
N/A	Ramp inside XWalk1?	Yes	N/A	Ram	inside XWalk2?	N/A
	Road Slope (%)	N/A	N/A	Clear	Space?	N/A
	Road X Slope (%)	N/A	N/A	Clear	Space to XWalk (in)	N/A
N/A	Any Obstructions?	N/A	N/A	Storn	n Grate/Utility Hazard?	N/A
	Obstruction Type			Storn	n Grate/Utility Type	
		N/A				N/A
			Yes	Surfa	ce Condition? (G/P)	Good

**CAMBELLTON DR** Street 1 Name StopSign Stop Condition-Street 2 Street 2 Name N/A Stop Condition-Street 1 N/A Possible Solutions: Remove & Replace Entire Ramp. Surveyor Notes: N/A PROW/ADA: R304.5.1, R304.2.2, R304.5.3
