Access Compliance Report

Public Rights-of-Way

(Curb Ramps)

Intersection ID: 23730	Main Street: PROVIDENCE_RD	Cross Street: CEDAR_CROFT_DR	Location: NE
ADA ID: 0B159C309E95	Ramp Type: Perp	Initial Pass/Fail: Fail	Overall Compliance: No
		Severity Score: 22.5

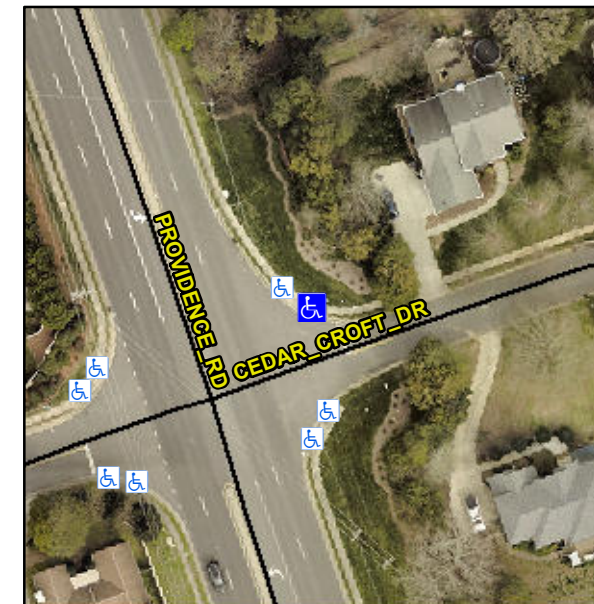
Compliance	Description	Data	Compliance	Description	Data
N/A	Ramp Length (in)	73.0	No	Ramp Slope (%)	8.6
No	Ramp Width (in)	46.5	No	Ramp XSlope (%)	4.6
N/A	Flare Type LT	N/A	N/A	Flare Type RT	N/A
N/A	Flare Slope LT (%)	N/A	N/A	Flare Slope RT (%)	N/A
N/A	Flare Traversable LT?	N/A	N/A	Flare Traversable RT?	N/A
N/A	Landing Length (in)	N/A	N/A	DWS Provided?	N/A
N/A	Landing Width (in)	N/A	N/A	DWS Contrast?	N/A
N/A	Landing Slope (%)	N/A	N/A	DWS Length (in)	N/A
N/A	Landing X Slope (%)	N/A	N/A	DWS Full Width?	N/A
N/A	Landing Curb? (Y/N)	N/A	N/A	DWS Offset (in)	N/A
N/A	Shared Landing?	N/A			
N/A	Gutter Ponding?	N/A	N/A	Gutter Slope (%)	N/A
N/A	Gutter Lip Ht (in)	N/A	N/A	Gutter X Slope (%)	N/A
N/A	Painted X Walk1?	No	N/A	Painted X Walk2?	N/A
	X Walk 1 Direction	To SE		X Walk 2 Direction	N/A
N/A	X Walk 1 Width (in)	N/A	N/A	X Walk 2 Width (in)	N/A
	X Walk 1 Slope (%)	0.4		X Walk 2 Slope (%)	N/A
	X Walk 1 X Slope (%)	3.9		X Walk 2 X Slope (%)	N/A

N/A	Ramp inside XWalk1?	N/A	N/A	Ramp inside XWalk2?	N/A
	Road Slope (%)	N/A	N/A	Clear Space?	N/A
	Road X Slope (%)	N/A	N/A	Clear Space to XWalk (in)	N/A
N/A	Any Obstructions?	N/A	N/A	Storm Grate/Utility Hazard?	N/A
	Obstruction Type			Storm Grate/Utility Type	
		N/A			N/A
			Yes	Surface Condition? (G/P)	Good

Possible Solutions:

Remove & Replace Entire Ramp.

R304.5.1, R304.2.2, R304.5.3
