# Access Compliance Report

## Public Rights-of-Way

### (Curb Ramps)

| Intersection ID: 12551 | Main Street: BELVEDERE_AV | Cross Street: CLUB_RD | Location: SE |

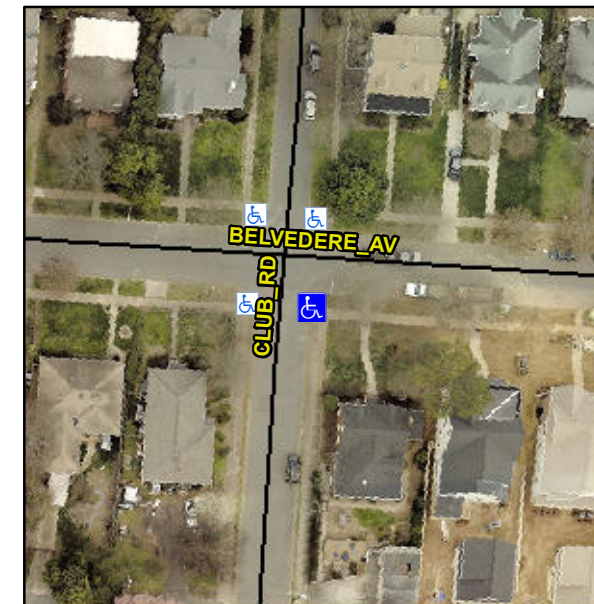
| ADA ID: 0B25F975F13A | Ramp Type: PerpDiag | Initial Pass/Fail: Fail | Overall Compliance: No |
| | | Severity Score: 10 | |

**Not Found, R304.5.1, R304.5.3**

| Compliance | Description | Data | Compliance | Description | Data |
|---|---|---|---|---|---|
| N/A | Ramp Length (in) | 56.0 | Yes | Ramp Slope (%) | 6.8 |
| No | Ramp Width (in) | 38.0 | No | Ramp XSlope (%) | 2.8 |

Possible Solutions:

**Remove & Replace Curb Ramp With Two New Directional Ramps or Equivalent.**
