Access Compliance Report

Public Rights-of-Way

(Curb Ramps)

Intersection ID: 50597	Main Street: DOWNY_BIRCH_RD	Cross Street: GRAY_WILLOW_RD	Location: NW
ADA ID: 0B2BFDD843A0	Ramp Type: Perp	Initial Pass/Fail: Fail	Overall Compliance: No
		Severity Score: 12.5

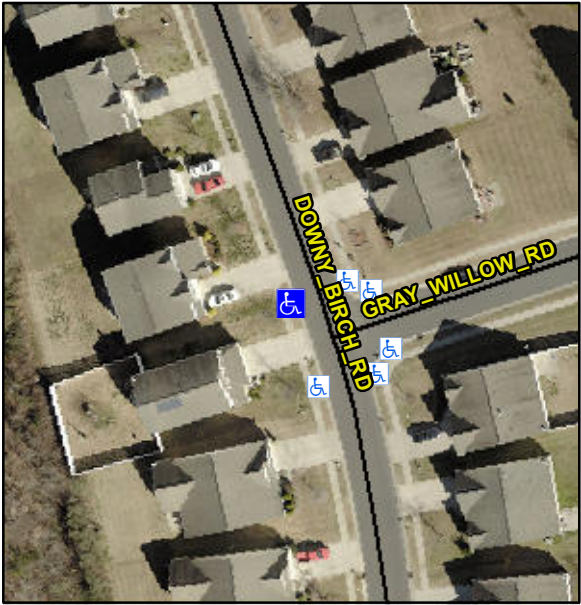
Possible Solutions:		Compliance	Description	Data
	Remove & Replace Entire Ramp.		No	Ramp Length (in)	48.0
			Yes	Ramp Width (in)	48.0
			N/A	Flare Type LT	N/A
			N/A	Flare Slope LT (%)	N/A
			N/A	Flare Traversable LT?	N/A
			N/A	Landing Length (in)	N/A
			N/A	Landing Width (in)	N/A
			N/A	Landing Slope (%)	N/A
			N/A	Landing X Slope (%)	N/A
<p>Surveyor Notes:</p> <p>N/A</p> <p>PROW/ADA:</p> <p>Not Found, R304.2.2</p>			N/A	Flare Type RT	N/A
			N/A	Flare Slope RT (%)	N/A
			N/A	Flare Traversable RT?	N/A
			N/A	DWS Provided?	N/A
			N/A	DWS Contrast?	N/A
			N/A	DWS Length (in)	N/A
			N/A	DWS Full Width?	N/A
			N/A	DWS Offset (in)	N/A
			N/A	Shared Landing?	N/A
			N/A	Gutter Ponding?	N/A
			N/A	Gutter Lip Ht (in)	N/A
			N/A	Painted X Walk1?	No
				X Walk 1 Direction	To E
			N/A	X Walk 1 Width (in)	N/A
				X Walk 1 Slope (%)	1.9
				X Walk 1 X Slope (%)	1.0

N/A	Ramp inside XWalk1?	N/A
			N/A	Road Slope (%)	N/A
			N/A	Road X Slope (%)	N/A
			N/A	Any Obstructions?	N/A
				Obstruction Type	
			N/A		
			N/A		
			N/A		
			N/A		
			N/A		
			N/A		
			N/A		
			N/A		
			N/A		
Total Cost:		\$ 1850.00			
			N/A		
			Yes	Surface Condition? (G/P)	Good
