# Access Compliance Report

## Public Rights-of-Way

### (Curb Ramps)

Intersection ID: 11058	Main Street: N_I-77_EXIT_10B_RA	Cross Street: N_I-77_EXIT_10C_RA	Location: NE
ADA ID: 0B342914F8C4	Ramp Type: Para	Initial Pass/Fail: Pass	Overall Compliance: No
Codes/Mitigation Info/Possible Solution		Field Measurements/Component Compliance

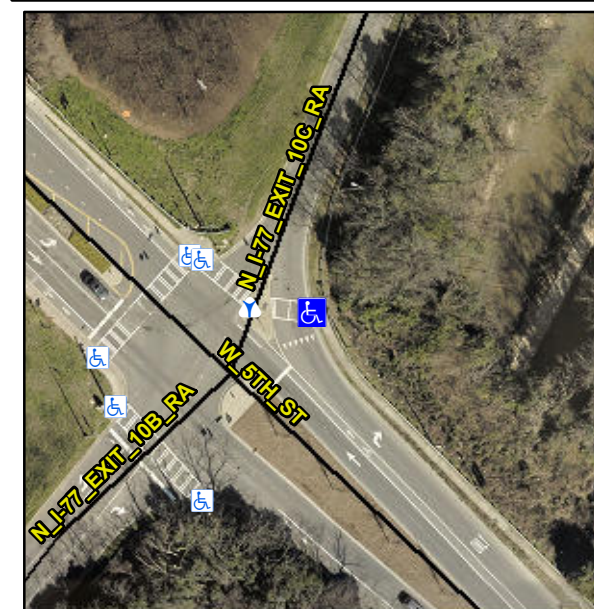
Surveyor Notes:

**RT RP < 5%**

PROW/ADA:

**Not Found, R304.2.1, R305.2**

Compliance	Description	Data	Compliance	Description	Data
N/A	Ramp Length LT (in)	67.0	N/A	Ramp Length RT (in)	65.0
Yes	Ramp Width LT (in)	78.0	Yes	Ramp Width RT (in)	76.0
Yes	Ramp Slope LT (%)	6.3	Yes	Ramp Slope RT (%)	2.7
Yes	Ramp XSlope LT (%)	0.7	Yes	Ramp XSlope RT (%)	0.1
Yes	Landing Length (in)	78.0	Yes	DWS Provided?	Yes
No	Landing Width (in)	46.0	Yes	DWS Contrast?	Yes
Yes	Landing Slope (%)	0.7	Yes	DWS Length (in)	24.5
Yes	Landing X Slope (%)	0.1	Yes	DWS Full Width?	Yes
N/A	Landing Curb? (Y/N)	No	No	DWS Offset (in)	4.5
N/A	Shared Landing?	No			
Yes	Gutter Ponding?	No	Yes	Gutter Slope (%)	3.4
Yes	Gutter Lip Ht (in)	0.0	Yes	Gutter X Slope (%)	0.7
N/A	Painted X Walk1?	Yes	N/A	Painted X Walk2?	N/A
	X Walk 1 Direction	To NW		X Walk 2 Direction	N/A
N/A	X Walk 1 Width (in)	115.0	N/A	X Walk 2 Width (in)	N/A
	X Walk 1 Slope (%)	6.1		X Walk 2 Slope (%)	N/A
	X Walk 1 X Slope (%)	0.9		X Walk 2 X Slope (%)	N/A
Yes	Ramp inside XWalk1?	Yes	N/A	Ramp inside XWalk2?	N/A

Road Slope (%)	N/A	N/A	Clear Space?	Yes
	Road X Slope (%)	N/A	N/A	Clear Space to XWalk (in)	N/A
Yes	Any Obstructions?	No	Yes	Storm Grate/Utility Hazard?	No
	Obstruction Type			Storm Grate/Utility Type	
		N/A			N/A
			Yes	Surface Condition? (G/P)	Good
			Replace	Curb Slope (%)	12.6

Possible Solutions:

**Remove & Replace Entire Ramp.**

Total Cost: \$ 1600.00
