Access Compliance Report

Public Rights-of-Way

(Curb Ramps)

Intersection ID: 6526	Main Street: CENTURY_OAKS_LN	Cross Street: MINERAL_SPRINGS_RD	Location: SE
ADA ID: 0B3F938672CD	Ramp Type: BlendTrans1	Initial Pass/Fail: Fail	Overall Compliance: No
Severity Score: 8.75			
Codes/Mitigation Info/Possible Solution		Field Measurements/Component Compliance

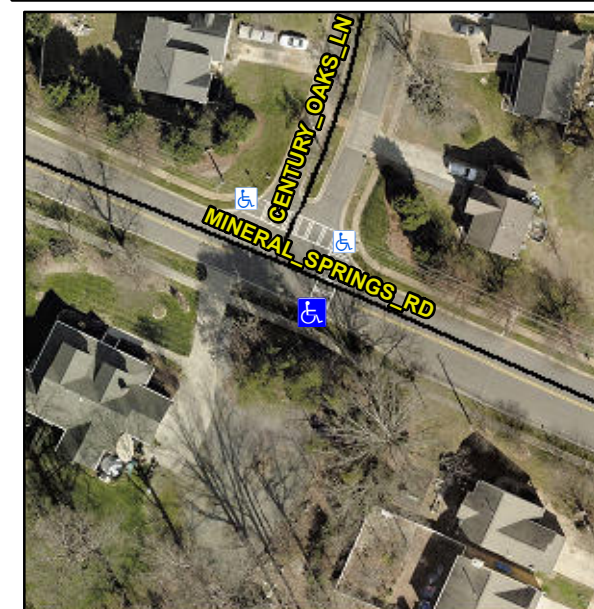
NO CURB, LNDG GAP 1.0

PROW/ADA:

R304.5.1

Compliance	Description	Data	Compliance	Description	Data
N/A	Ramp Length (in)	99.0	Yes	BlendTrans Slope (%)	3.5
No	Ramp Width (in)	47.0	Yes	BlendTrans XSlope (%)	0.0
N/A	Flare Type LT	N/A	N/A	Flare Type RT	N/A
N/A	Flare Slope LT (%)	N/A	N/A	Flare Slope RT (%)	N/A
N/A	Flare Traversable LT?	N/A	N/A	Flare Traversable RT?	N/A
N/A	Landing Length (in)	N/A	N/A	DWS Provided?	N/A
N/A	Landing Width (in)	N/A	N/A	DWS Contrast?	N/A
N/A	Landing Slope (%)	N/A	N/A	DWS Length (in)	N/A
N/A	Landing X Slope (%)	N/A	N/A	DWS Full Width?	N/A
N/A	Landing Curb? (Y/N)	N/A	N/A	DWS Offset (in)	N/A
N/A	Shared Landing?	N/A			
N/A	Gutter Ponding?	N/A	N/A	Gutter Slope (%)	N/A
N/A	Gutter Lip Ht (in)	1.0	N/A	Gutter X Slope (%)	N/A
N/A	Painted X Walk1?	Yes	N/A	Painted X Walk2?	N/A
	X Walk 1 Direction	To NE		X Walk 2 Direction	N/A
	X Walk 1 Width (in)	112.0		X Walk 2 Width (in)	N/A
	X Walk 1 Slope (%)	4.0		X Walk 2 Slope (%)	N/A
	X Walk 1 X Slope (%)	1.0		X Walk 2 X Slope (%)	N/A

N/A	Ramp inside XWalk1?	Yes	N/A	Ramp inside XWalk2?	N/A
	Road Slope (%)	1.0		Clear Space?	N/A
	Road X Slope (%)	4.0	N/A	Clear Space to XWalk (in)	N/A
N/A	Any Obstructions?	N/A	N/A	Storm Grate/Utility Hazard?	N/A
	Obstruction Type			Storm Grate/Utility Type	
		N/A			N/A
			Yes	Surface Condition? (G/P)	Good
			N/A	Curb Slope (%)	N/A

Possible Solutions:

Remove & Replace Curb Ramp With Two New Directional Ramps or Equivalent.
