# Access Compliance Report

## Public Rights-of-Way

### (Curb Ramps)

Intersection ID: N/A	Main Street: CHARLOTTE_PARK_DR	Cross Street: N/A	Location: SW
ADA ID: 0B447DAEE31F	Ramp Type: PerpDiag	Initial Pass/Fail: Pass	Overall Compliance: No
		Severity Score: 20

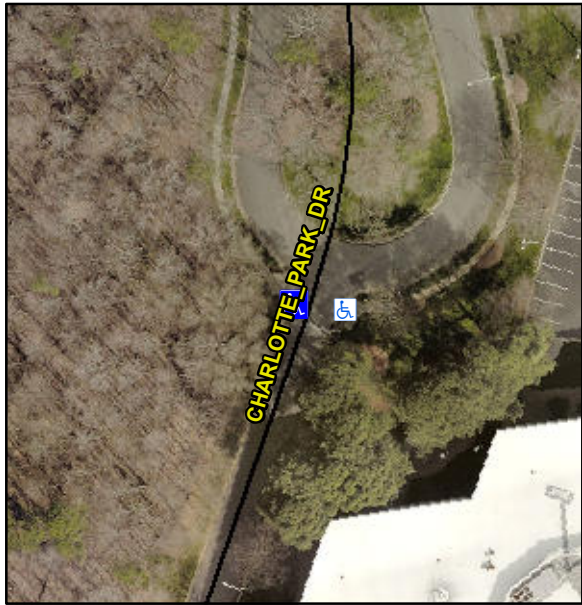
Possible Solutions:		Compliance	Description	Data	Compliance	Description	Data
	<b>Remove &amp; Replace Curb Ramp With Two New Directional Ramps or Equivalent. Gutter Ponding Observed.</b>		N/A	Ramp Length (in)	116.5	Yes	Ramp Slope (%)	5.8
			Yes	Ramp Width (in)	65.0	Yes	Ramp XSlope (%)	0.5
			N/A	Flare Type LT	Sloped	N/A	Flare Type RT	N/A
			N/A	Flare Slope LT (%)	7.4	N/A	Flare Slope RT (%)	9.9
			N/A	Flare Traversable LT?	No	N/A	Flare Traversable RT?	No
			No	Landing Length (in)	N/A	No	DWS Provided?	No
			No	Landing Width (in)	N/A	N/A	DWS Contrast?	No
			No	Landing Slope (%)	N/A	N/A	DWS Length (in)	N/A
			No	Landing X Slope (%)	N/A	N/A	DWS Full Width?	No
<p>Surveyor Notes:</p> <p><b>N/A</b></p> <p>PROW/ADA:</p> <p><b>R304.2.1, R304.2.2-Perp, R304.3.2-Para, R304.5.3, R305, R302.7</b></p>			N/A	Landing Curb? (Y/N)	No	N/A	DWS Offset (in)	N/A

N/A	Shared Landing?	No			
			No	Gutter Ponding?	Yes	Yes	Gutter Slope (%)	2.4
			Yes	Gutter Lip Ht (in)	0.0	Yes	Gutter X Slope (%)	0.2
			N/A	Painted X Walk1?	No	N/A	Painted X Walk2?	No
				X Walk 1 Direction	To E		X Walk 2 Direction	To N
			N/A	X Walk 1 Width (in)	N/A	N/A	X Walk 2 Width (in)	N/A
				X Walk 1 Slope (%)	2.4		X Walk 2 Slope (%)	5.2
				X Walk 1 X Slope (%)	2.0		X Walk 2 X Slope (%)	1.8
			N/A	Ramp inside XWalk1?	N/A	N/A	Ramp inside XWalk2?	N/A
			Road Slope (%)	0.8	N/A	Clear Space?	Yes	
			Road X Slope (%)	4.9	N/A	Clear Space to XWalk (in)	N/A	
		Yes	Any Obstructions?	No	Yes	Storm Grate/Utility Hazard?	No	
			Obstruction Type			Storm Grate/Utility Type		
					N/A		N/A	
						Yes	Surface Condition? (G/P)	Good
Total Cost:		\$ 3700.00
