Access Compliance Report

Public Rights-of-Way

(Curb Ramps)

Intersection ID: 18847	Main Street: BRACE_RD	Cross Street: RAMA_RD	Location: N
ADA ID: 0B5202FC3C64	Ramp Type: PerpDiag	Initial Pass/Fail: Fail	Overall Compliance: No
Codes/Mitigation Info/Possible Solution			Severity Score: 25
			Field Measurements/Component Compliance

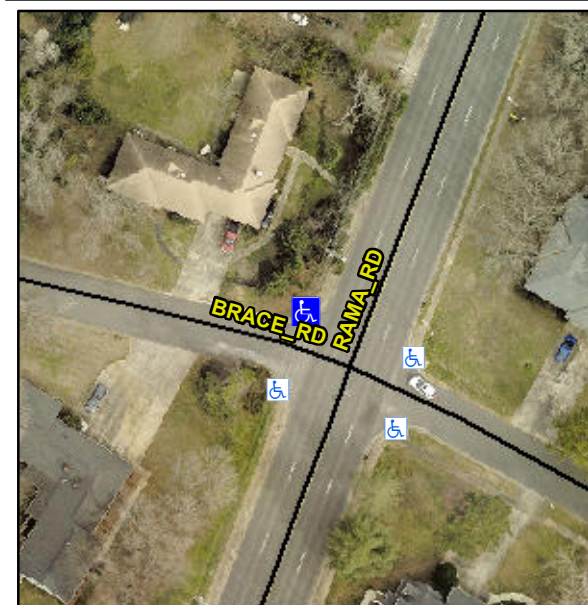
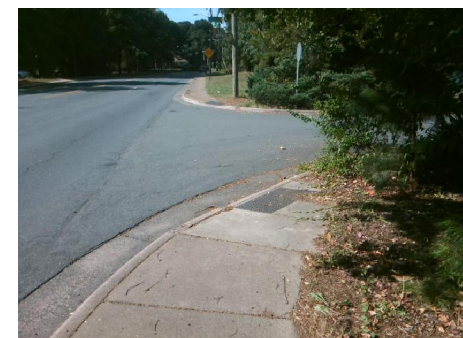
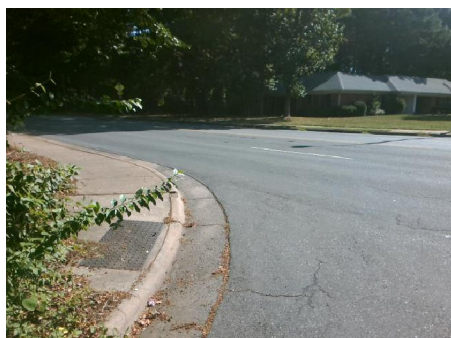
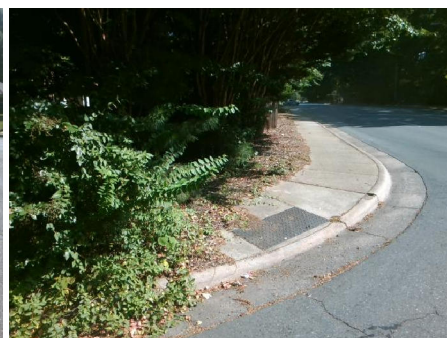
Not Found, R304.2.2, R304.5.3

Compliance	Description	Data	Compliance	Description	Data
N/A	Ramp Length (in)	60.0	No	Ramp Slope (%)	9.6
Yes	Ramp Width (in)	48.0	No	Ramp XSlope (%)	5.3
N/A	Flare Type LT	N/A	N/A	Flare Type RT	N/A
N/A	Flare Slope LT (%)	N/A	N/A	Flare Slope RT (%)	N/A
N/A	Flare Traversable LT?	N/A	N/A	Flare Traversable RT?	N/A
N/A	Landing Length (in)	N/A	N/A	DWS Provided?	N/A
N/A	Landing Width (in)	N/A	N/A	DWS Contrast?	N/A
N/A	Landing Slope (%)	N/A	N/A	DWS Length (in)	N/A
N/A	Landing X Slope (%)	N/A	N/A	DWS Full Width?	N/A
N/A	Landing Curb? (Y/N)	N/A	N/A	DWS Offset (in)	N/A
N/A	Shared Landing?	N/A			
N/A	Gutter Ponding?	N/A	N/A	Gutter Slope (%)	N/A
N/A	Gutter Lip Ht (in)	N/A	N/A	Gutter X Slope (%)	N/A
N/A	Painted X Walk1?	No	N/A	Painted X Walk2?	No
	X Walk 1 Direction	To SW		X Walk 2 Direction	To SE
N/A	X Walk 1 Width (in)	N/A	N/A	X Walk 2 Width (in)	N/A
	X Walk 1 Slope (%)	1.1		X Walk 2 Slope (%)	4.2
	X Walk 1 X Slope (%)	4.9		X Walk 2 X Slope (%)	0.2

N/A	Ramp inside XWalk1?	N/A	N/A	Ramp inside XWalk2?	N/A
	Road Slope (%)	3.4	N/A	Clear Space?	N/A
	Road X Slope (%)	8.9	N/A	Clear Space to XWalk (in)	N/A
N/A	Any Obstructions?	N/A	N/A	Storm Grate/Utility Hazard?	N/A
	Obstruction Type			Storm Grate/Utility Type	
		N/A			N/A
			Yes	Surface Condition? (G/P)	Good

Possible Solutions:

Remove & Replace Curb Ramp With Two New Directional Ramps or Equivalent.
