Access Compliance Report

Public Rights-of-Way

(Curb Ramps)

Intersection ID: 14115	Main Street: TOOMEY_AV	Cross Street: W_TREMONT_AV	Location: S
ADA ID: 0B60C564EF3A	Ramp Type: ParaDiag	Initial Pass/Fail: Fail	Overall Compliance: No
			Severity Score: 13.75

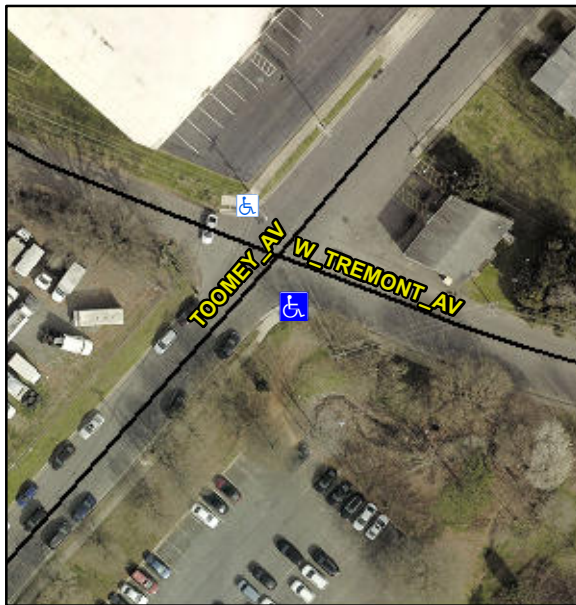
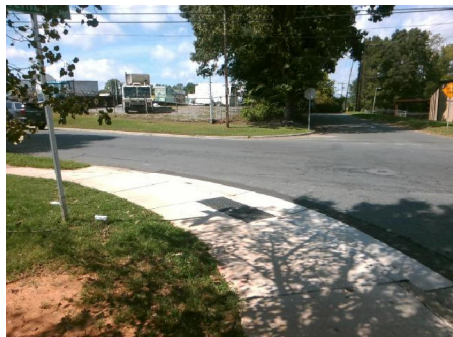
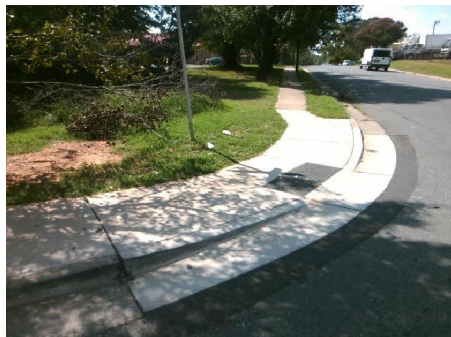
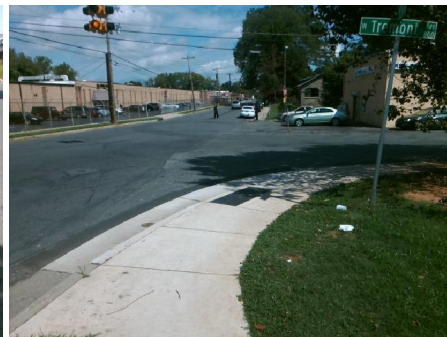
LT RP < 5%

R304.5.3, R304.3.2

Compliance	Description	Data	Compliance	Description	Data
N/A	Ramp Length LT (in)	71.0	N/A	Ramp Length RT (in)	52.0
Yes	Ramp Width LT (in)	61.0	Yes	Ramp Width RT (in)	59.0
Yes	Ramp Slope LT (%)	2.9	No	Ramp Slope RT (%)	8.9
No	Ramp XSlope LT (%)	3.5	Yes	Ramp XSlope RT (%)	1.4
N/A	Landing Length (in)	N/A	N/A	DWS Provided?	N/A
N/A	Landing Width (in)	N/A	N/A	DWS Contrast?	N/A
N/A	Landing Slope (%)	N/A	N/A	DWS Length (in)	N/A
N/A	Landing X Slope (%)	N/A	N/A	DWS Full Width?	N/A
N/A	Landing Curb? (Y/N)	N/A	N/A	DWS Offset (in)	N/A
N/A	Shared Landing?	N/A			
N/A	Gutter Ponding?	N/A	N/A	Gutter Slope (%)	N/A
N/A	Gutter Lip Ht (in)	N/A	N/A	Gutter X Slope (%)	N/A
N/A	Painted X Walk1?	No	N/A	Painted X Walk2?	No
	X Walk 1 Direction	To NE		X Walk 2 Direction	To NW
N/A	X Walk 1 Width (in)	N/A	N/A	X Walk 2 Width (in)	N/A
	X Walk 1 Slope (%)	1.0		X Walk 2 Slope (%)	3.5
	X Walk 1 X Slope (%)	1.9		X Walk 2 X Slope (%)	0.6
N/A	Ramp inside XWalk1?	N/A	N/A	Ramp inside XWalk2?	N/A

Road Slope (%)	0.6	N/A	Clear Space?	N/A
	Road X Slope (%)	0.7	N/A	Clear Space to XWalk (in)	N/A
N/A	Any Obstructions?	N/A	N/A	Storm Grate/Utility Hazard?	N/A
	Obstruction Type			Storm Grate/Utility Type	
		N/A			N/A
			Yes	Surface Condition? (G/P)	Good
			N/A	Curb Slope (%)	11.6

Remove & Replace Curb Ramp With Two New Directional Ramps or Equivalent.
