# Access Compliance Report

## Public Rights-of-Way

### (Curb Ramps)

Intersection ID: 29364	Main Street: JOHN_MCGRAW_LN	Cross Street: SUMMIT_HILLS_DR	Location: S
ADA ID: 0B742B311D91	Ramp Type: Perp	Initial Pass/Fail: Fail	Overall Compliance: No
Severity Score: 8.75			
Codes/Mitigation Info/Possible Solution		Field Measurements/Component Compliance

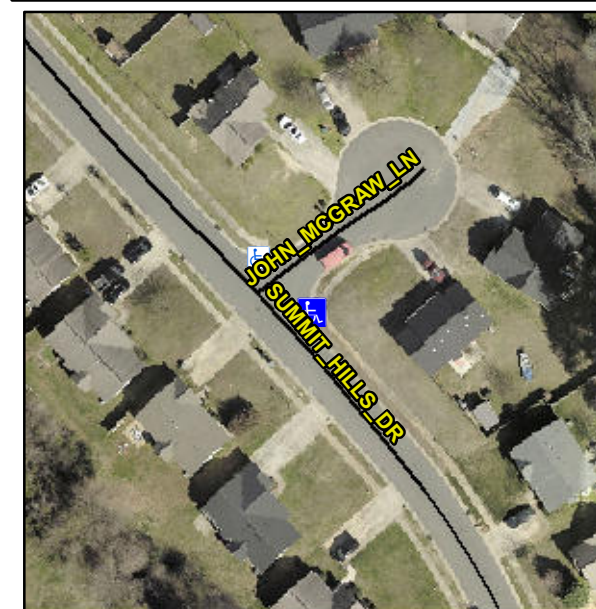
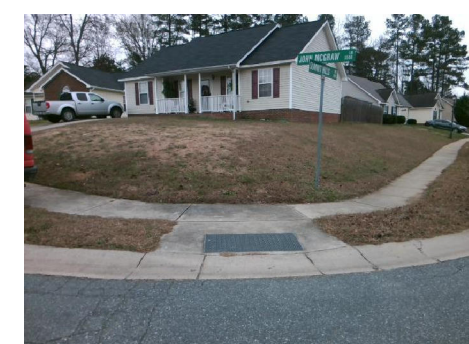
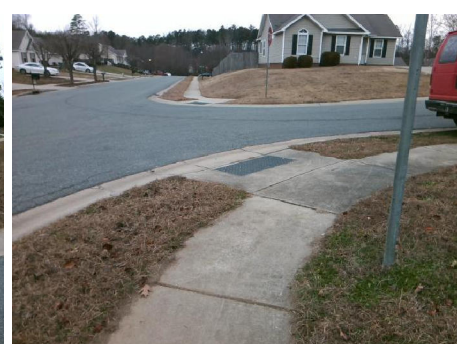
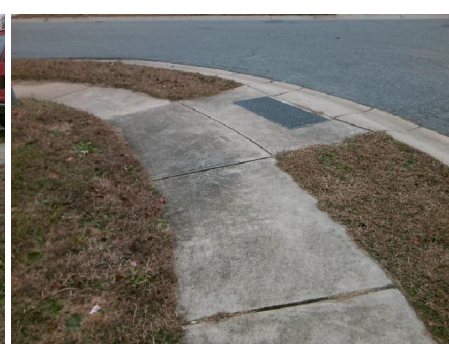
Compliance	Description	Data	Compliance	Description	Data
N/A	Ramp Length (in)	49.5	Yes	Ramp Slope (%)	6.3
No	Ramp Width (in)	46.0	Yes	Ramp XSlope (%)	1.4
N/A	Flare Type LT	N/A	N/A	Flare Type RT	N/A
N/A	Flare Slope LT (%)	N/A	N/A	Flare Slope RT (%)	N/A
N/A	Flare Traversable LT?	N/A	N/A	Flare Traversable RT?	N/A
N/A	Landing Length (in)	N/A	N/A	DWS Provided?	N/A
N/A	Landing Width (in)	N/A	N/A	DWS Contrast?	N/A
N/A	Landing Slope (%)	N/A	N/A	DWS Length (in)	N/A
N/A	Landing X Slope (%)	N/A	N/A	DWS Full Width?	N/A
N/A	Landing Curb? (Y/N)	N/A	N/A	DWS Offset (in)	N/A
N/A	Shared Landing?	N/A			
N/A	Gutter Ponding?	N/A	N/A	Gutter Slope (%)	N/A
N/A	Gutter Lip Ht (in)	N/A	N/A	Gutter X Slope (%)	N/A
N/A	Painted X Walk1?	No	N/A	Painted X Walk2?	N/A
	X Walk 1 Direction	To N		X Walk 2 Direction	N/A
N/A	X Walk 1 Width (in)	N/A	N/A	X Walk 2 Width (in)	N/A
	X Walk 1 Slope (%)	1.1		X Walk 2 Slope (%)	N/A
	X Walk 1 X Slope (%)	0.1		X Walk 2 X Slope (%)	N/A

N/A	Ramp inside XWalk1?	N/A	N/A	Ramp inside XWalk2?	N/A
	Road Slope (%)	N/A	N/A	Clear Space?	N/A
	Road X Slope (%)	N/A	N/A	Clear Space to XWalk (in)	N/A
N/A	Any Obstructions?	N/A	N/A	Storm Grate/Utility Hazard?	N/A
	Obstruction Type			Storm Grate/Utility Type	
		N/A			N/A
			Yes	Surface Condition? (G/P)	Good

Possible Solutions:

**Remove & Replace Entire Ramp.**
