# Access Compliance Report

## Public Rights-of-Way

### (Curb Ramps)

Intersection ID: 10272	Main Street: E_33RD_ST	Cross Street: N_DAVIDSON_ST	Location: S
ADA ID: 0B7C523F7768	Ramp Type: BlendTrans1	Initial Pass/Fail: Fail	Overall Compliance: No
			Severity Score: 33.75

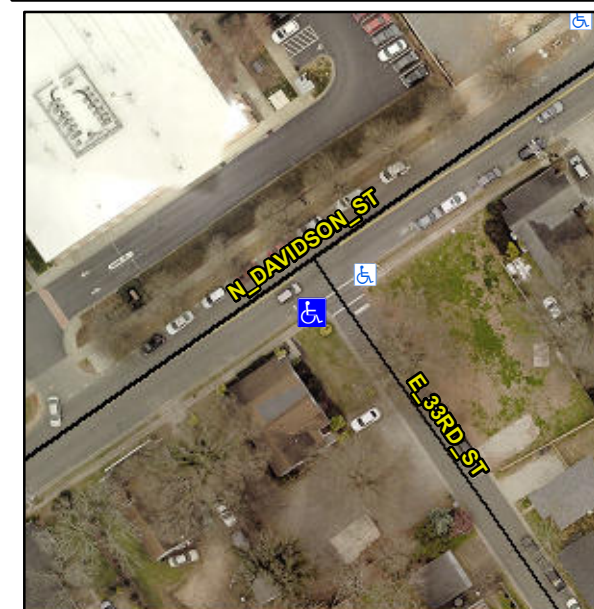
**Not Found, R304.5.1, R304.5.3**

Compliance	Description	Data	Compliance	Description	Data
N/A	Ramp Length (in)	112.0	Yes	BlendTrans Slope (%)	0.6
No	Ramp Width (in)	47.0	No	BlendTrans XSlope (%)	10.4
N/A	Flare Type LT	N/A	N/A	Flare Type RT	N/A
N/A	Flare Slope LT (%)	N/A	N/A	Flare Slope RT (%)	N/A
N/A	Flare Traversable LT?	N/A	N/A	Flare Traversable RT?	N/A
N/A	Landing Length (in)	N/A	N/A	DWS Provided?	N/A
N/A	Landing Width (in)	N/A	N/A	DWS Contrast?	N/A
N/A	Landing Slope (%)	N/A	N/A	DWS Length (in)	N/A
N/A	Landing X Slope (%)	N/A	N/A	DWS Full Width?	N/A
N/A	Landing Curb? (Y/N)	N/A	N/A	DWS Offset (in)	N/A
N/A	Shared Landing?	N/A			
N/A	Gutter Ponding?	N/A	N/A	Gutter Slope (%)	N/A
N/A	Gutter Lip Ht (in)	N/A	N/A	Gutter X Slope (%)	N/A
N/A	Painted X Walk1?	Yes	N/A	Painted X Walk2?	N/A
	X Walk 1 Direction	To NE		X Walk 2 Direction	N/A
	X Walk 1 Width (in)	108.0		X Walk 2 Width (in)	N/A
	X Walk 1 Slope (%)	2.2		X Walk 2 Slope (%)	N/A
	X Walk 1 X Slope (%)	3.3		X Walk 2 X Slope (%)	N/A

N/A	Ramp inside XWalk1?	Yes	N/A	Ramp inside XWalk2?	N/A
	Road Slope (%)	3.3		Clear Space?	N/A
	Road X Slope (%)	2.2	N/A	Clear Space to XWalk (in)	N/A
N/A	Any Obstructions?	N/A	N/A	Storm Grate/Utility Hazard?	N/A
	Obstruction Type			Storm Grate/Utility Type	
		N/A			N/A
			Yes	Surface Condition? (G/P)	Good
			No	Curb Slope (%)	14.5

**Remove & Replace Curb Ramp With Two New Directional Ramps or Equivalent.**

Total Cost: \$ 3200.00
