Access Compliance Report

Public Rights-of-Way

(Curb Ramps)

| Intersection ID: 10018432 | Main Street: WITHAM_PASSAGE | Cross Street: N/A | Location: E |

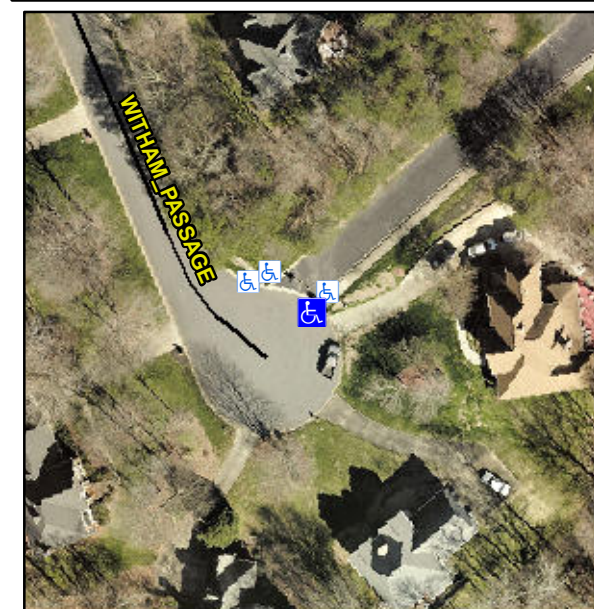
| ADA ID: 0B7D6F31A98C | Ramp Type: Perp | Initial Pass/Fail: Fail | Overall Compliance: No |

Not Found, R304.2.2

| Compliance | Description | Data | Compliance | Description | Data |
|---|---|---|---|---|---|
| N/A | Ramp Length (in) | 48.5 | No | Ramp Slope (%) | 12.5 |

Possible Solutions:

Remove & Replace Entire Ramp.

Total Cost: \$ 1850.00
