# Access Compliance Report

## Public Rights-of-Way

### (Curb Ramps)

| Intersection ID: 21772 | Main Street: DOVERSHIRE_RD | Cross Street: SARDIS_RD | Location: S |

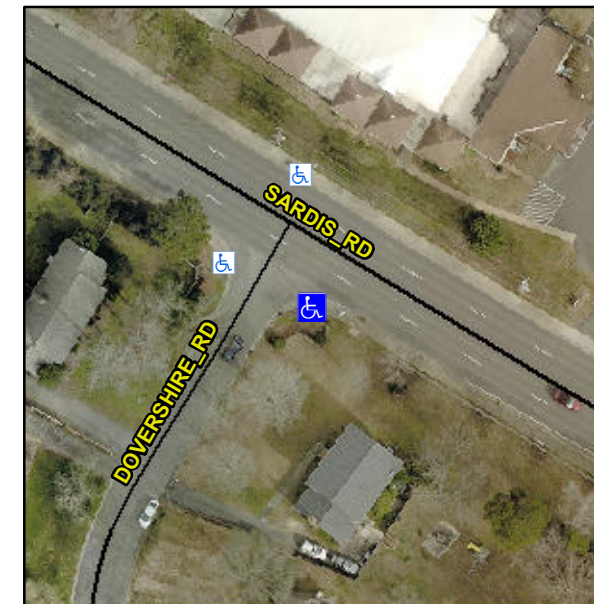
| ADA ID: 0B8BF1E698FA | Ramp Type: PerpDiag | Initial Pass/Fail: Fail | Overall Compliance: No |

**Not Found, R304.5.1, R304.2.2**

| Compliance | Description | Data | Compliance | Description | Data |
|---|---|---|---|---|---|
| N/A | Ramp Length (in) | 61.0 | No | Ramp Slope (%) | 10.0 |
| No | Ramp Width (in) | 43.0 | Yes | Ramp XSlope (%) | 1.4 |

**Remove & Replace Curb Ramp With Two New Directional Ramps or Equivalent.**

Total Cost: \$ 3200.00
