Access Compliance Report

Public Rights-of-Way

(Curb Ramps)

Intersection ID: 7457	Main Street: CANTERWOOD_DR	Cross Street: ELGYWOOD_LN	Location: SW
ADA ID: 0B9165D5F70D	Ramp Type: Para	Initial Pass/Fail: Fail	Overall Compliance: No
Severity Score: 12.5			
Codes/Mitigation Info/Possible Solution		Field Measurements/Component Compliance

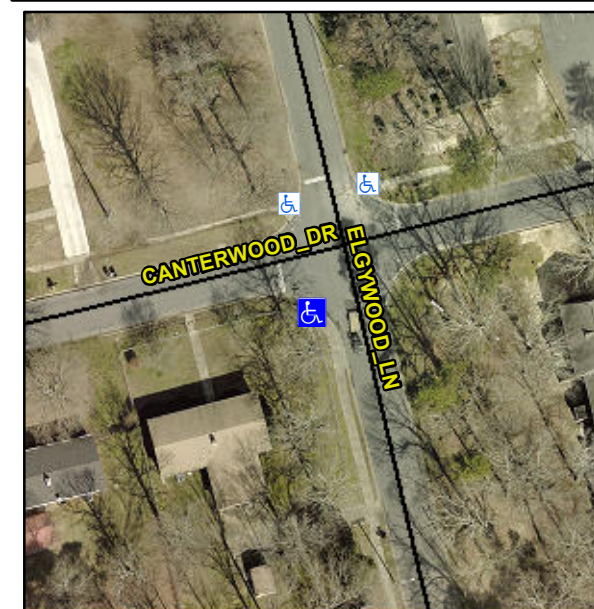
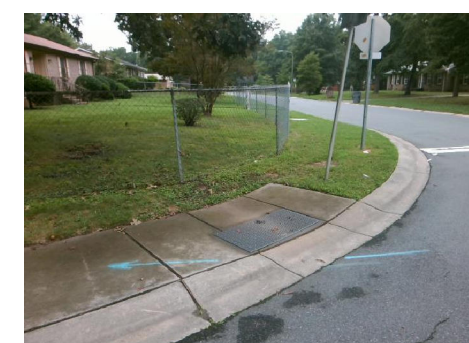
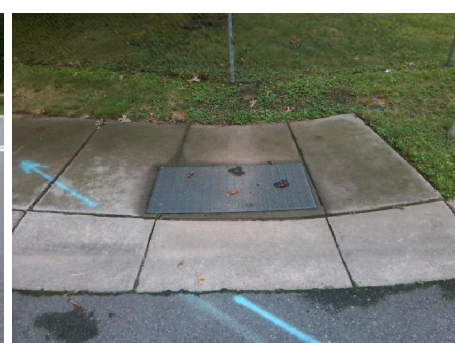
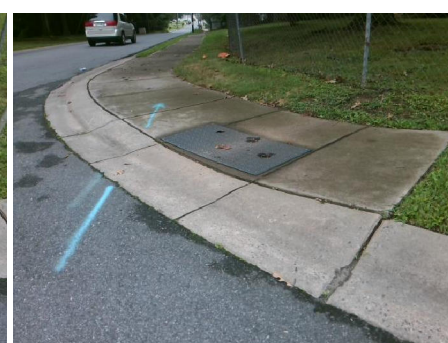
LT RP < 5%, NO RT SW, CURB GAP 1.0

Compliance	Description	Data	Compliance	Description	Data
N/A	Ramp Length LT (in)	34.0	N/A	Ramp Length RT (in)	28.0
Yes	Ramp Width LT (in)	59.0	Yes	Ramp Width RT (in)	59.5
Yes	Ramp Slope LT (%)	4.0	No	Ramp Slope RT (%)	8.4
Yes	Ramp XSlope LT (%)	1.3	Yes	Ramp XSlope RT (%)	0.5
N/A	Landing Length (in)	N/A	N/A	DWS Provided?	N/A
N/A	Landing Width (in)	N/A	N/A	DWS Contrast?	N/A
N/A	Landing Slope (%)	N/A	N/A	DWS Length (in)	N/A
N/A	Landing X Slope (%)	N/A	N/A	DWS Full Width?	N/A
N/A	Landing Curb? (Y/N)	N/A	N/A	DWS Offset (in)	N/A
N/A	Shared Landing?	N/A			
N/A	Gutter Ponding?	N/A	N/A	Gutter Slope (%)	N/A
N/A	Gutter Lip Ht (in)	N/A	N/A	Gutter X Slope (%)	N/A
N/A	Painted X Walk1?	No	N/A	Painted X Walk2?	N/A
	X Walk 1 Direction	To NW		X Walk 2 Direction	N/A
N/A	X Walk 1 Width (in)	N/A	N/A	X Walk 2 Width (in)	N/A
	X Walk 1 Slope (%)	2.5		X Walk 2 Slope (%)	N/A
	X Walk 1 X Slope (%)	1.0		X Walk 2 X Slope (%)	N/A
N/A	Ramp inside XWalk1?	N/A	N/A	Ramp inside XWalk2?	N/A

Road Slope (%)	N/A	N/A	Clear Space?	N/A
	Road X Slope (%)	N/A	N/A	Clear Space to XWalk (in)	N/A
N/A	Any Obstructions?	N/A	N/A	Storm Grate/Utility Hazard?	N/A
	Obstruction Type			Storm Grate/Utility Type	
		N/A			N/A
			Yes	Surface Condition? (G/P)	Good
			N/A	Curb Slope (%)	11.6

Remove & Replace Entire Ramp.

R304.3.2
