# Access Compliance Report

## Public Rights-of-Way

### (Curb Ramps)

| Intersection ID: 27432 | Main Street: BALLANTYNE COMMONS PY | Cross Street: DURANT BV | Location: NW |

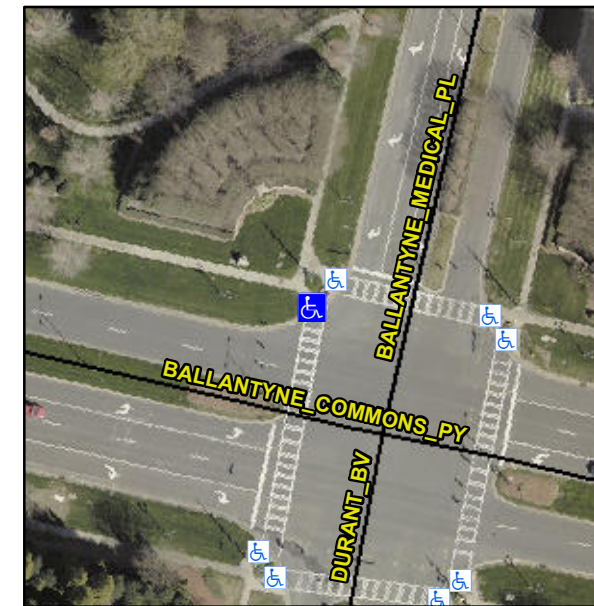
**Not Found, R304.5.3, R305**

| Compliance | Description | Data | Compliance | Description | Data |
|---|---|---|---|---|---|
| Yes | Ramp Width (in) | 62.0 | No | Ramp XSlope (%) | 5.0 |
| Yes | Landing Length (in) | 92.0 | No | DWS Provided? | No |
| No | Landing X Slope (%) | 4.1 | N/A | DWS Full Width? | No |

**Remove & Replace Entire Ramp.**

Total Cost: \$ 1850.00
