Access Compliance Report

Public Rights-of-Way

(Curb Ramps)

Intersection ID: 14681	Main Street: FAIRWOOD_AV	Cross Street: GRIFFITH_ST	Location: S
ADA ID: 0B973757DC0F	Ramp Type: Perp	Initial Pass/Fail: Fail	Overall Compliance: No
Severity Score: 22.5			
Codes/Mitigation Info/Possible Solution		Field Measurements/Component Compliance

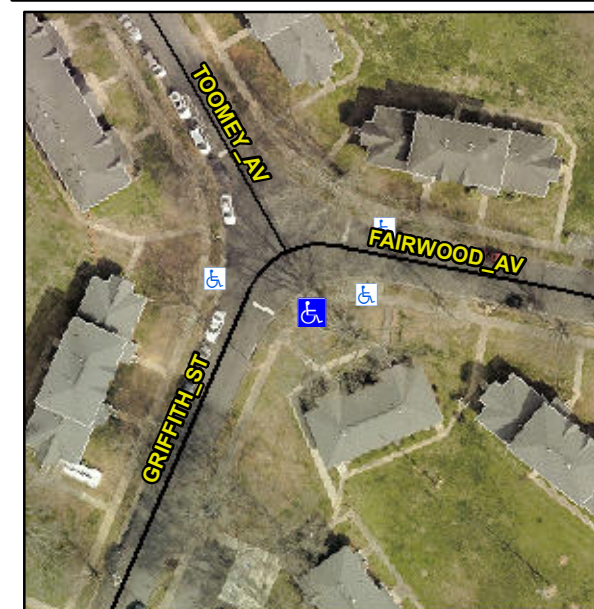
R304.5.1, R304.2.2, R304.5.3

Compliance	Description	Data	Compliance	Description	Data
N/A	Ramp Length (in)	62.0	No	Ramp Slope (%)	9.6
No	Ramp Width (in)	45.0	No	Ramp XSlope (%)	2.2
N/A	Flare Type LT	N/A	N/A	Flare Type RT	N/A
N/A	Flare Slope LT (%)	N/A	N/A	Flare Slope RT (%)	N/A
N/A	Flare Traversable LT?	N/A	N/A	Flare Traversable RT?	N/A
N/A	Landing Length (in)	N/A	N/A	DWS Provided?	N/A
N/A	Landing Width (in)	N/A	N/A	DWS Contrast?	N/A
N/A	Landing Slope (%)	N/A	N/A	DWS Length (in)	N/A
N/A	Landing X Slope (%)	N/A	N/A	DWS Full Width?	N/A
N/A	Landing Curb? (Y/N)	N/A	N/A	DWS Offset (in)	N/A
N/A	Shared Landing?	N/A			
N/A	Gutter Ponding?	N/A	N/A	Gutter Slope (%)	N/A
N/A	Gutter Lip Ht (in)	N/A	N/A	Gutter X Slope (%)	N/A
N/A	Painted X Walk1?	No	N/A	Painted X Walk2?	N/A
	X Walk 1 Direction	To NW		X Walk 2 Direction	N/A
N/A	X Walk 1 Width (in)	N/A	N/A	X Walk 2 Width (in)	N/A
	X Walk 1 Slope (%)	0.3		X Walk 2 Slope (%)	N/A
	X Walk 1 X Slope (%)	5.9		X Walk 2 X Slope (%)	N/A

Possible Solutions:

Remove & Replace Entire Ramp.

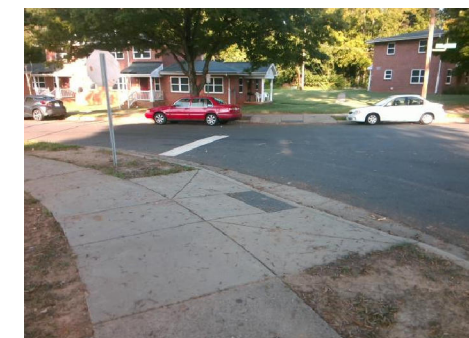
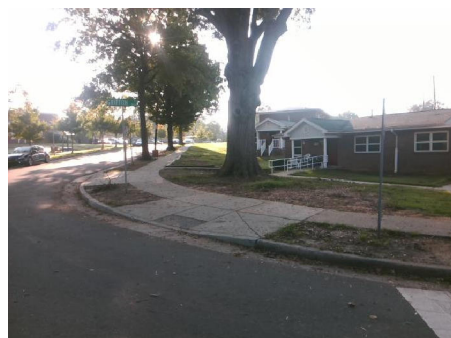
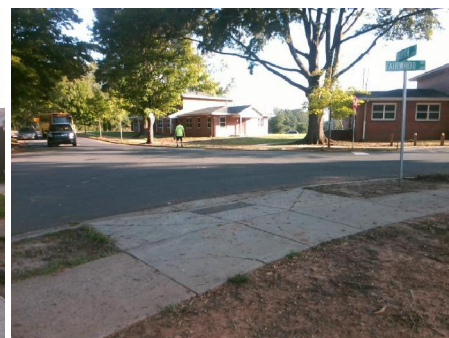
N/A	Ramp inside XWalk1?	N/A	N/A	Ramp inside XWalk2?	N/A
	Road Slope (%)	N/A	N/A	Clear Space?	N/A
	Road X Slope (%)	N/A	N/A	Clear Space to XWalk (in)	N/A
N/A	Any Obstructions?	N/A	N/A	Storm Grate/Utility Hazard?	N/A
	Obstruction Type			Storm Grate/Utility Type	
		N/A			N/A
			Yes	Surface Condition? (G/P)	Good

Street 1 Name **GRIFFITH ST**
 Stop Condition-Street 2 **StopSign**
 Street 2 Name **N/A**
 Stop Condition-Street 1 **N/A**
