## **Access Compliance Report Public Rights-of-Way** (Curb Ramps)

Intersection ID: 10033044 Main Street: NOLLEY\_CT Cross Street: N/A Location: **Overall Compliance: No ADA ID: 0B9A1EB6F57E** Ramp Type: BlendTrans1 Initial Pass/Fail: Fail Severity Score: 21.25

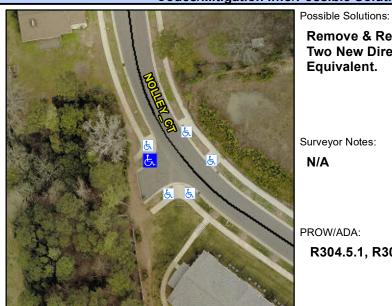
| | | N/A |
|---|---|---|
| R304.5.1, R304.5.3 | | N/A |

| N/A | Ramp Length (in) | 95.0 | Yes | BlendTrans Slope (%) | 2.6 |
|---|---|---|---|---|---|
| No | Ramp Width (in) | 45.0 | No | BlendTrans XSlope (%) | 5.7 |

**Remove & Replace Curb Ramp With** Two New Directional Ramps or Equivalent.

| | | N/A |
|---|---|---|
| Total Cost: | \$<br>3200.00 | |
