# Access Compliance Report

## Public Rights-of-Way

### (Curb Ramps)

| Intersection ID: 46189 | Main Street: GALARDIA_RD | Cross Street: YAUPON_RD | Location: | N |

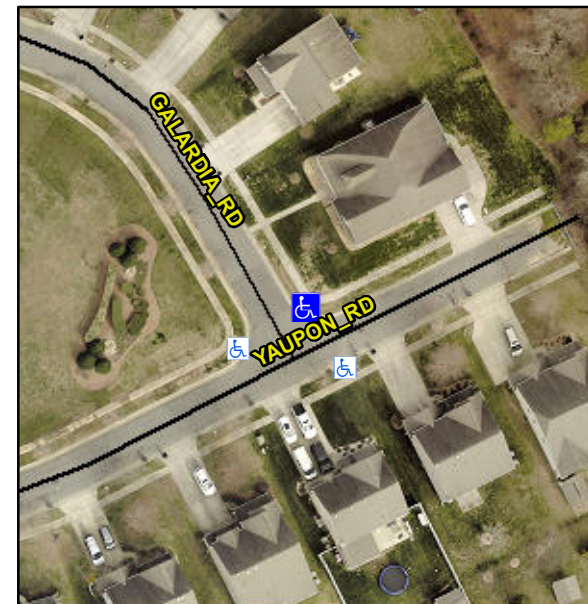
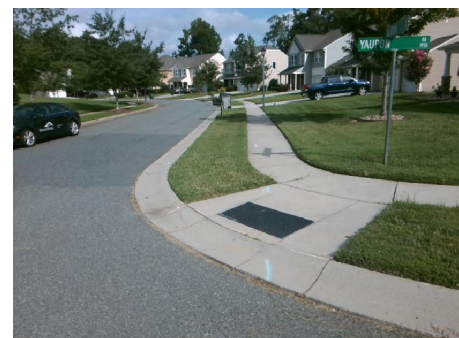
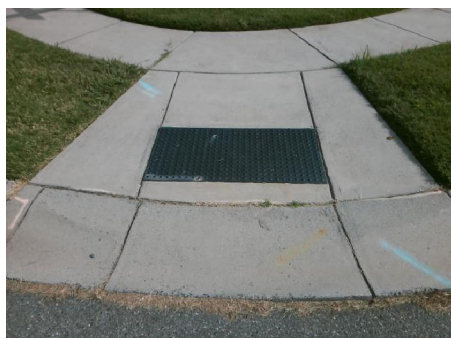
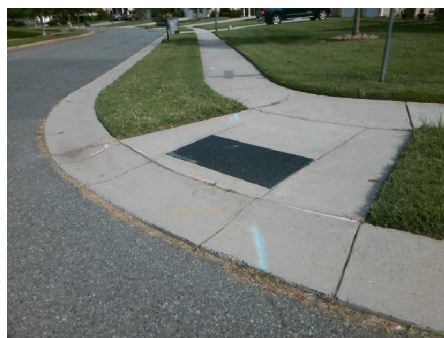
| ADA ID: 0B9C449456D5 | Ramp Type: BlendTrans1 | Initial Pass/Fail: Pass | Overall Compliance: No | Severity Score: 20 |

**Not Found, R304.2.1, R304.5.3, R305.2, R302.7, R302.7.2, R304.5.4**

| Compliance | Description | Data | Compliance | Description | Data |
|---|---|---|---|---|---|
| No | Landing Length (in) | 47.5 | Yes | DWS Provided? | Yes |
| No | Landing X Slope (%) | 3.2 | Yes | DWS Full Width? | Yes |
| No | Gutter Ponding? | Yes | No | Gutter Slope (%) | 12.4 |
| No | Gutter Lip Ht (in) | 2.0 | No | Gutter X Slope (%) | 2.8 |

**Remove & Replace Curb Ramp With Two New Directional Ramps or Equivalent. Remove & Replace Gutter.**
