Access Compliance Report

Public Rights-of-Way (Curb Ramps)

Intersection ID: 20503	Main Street: EMERALD_MEADOW_LN	Cross Street: MORNING_MIST_LN	Location:	N
ADA ID: 0BA5F0406390	Ramp Type: Perp	Initial Pass/Fail: Fail	Overall Compliance: No	Severity Score: 26.25

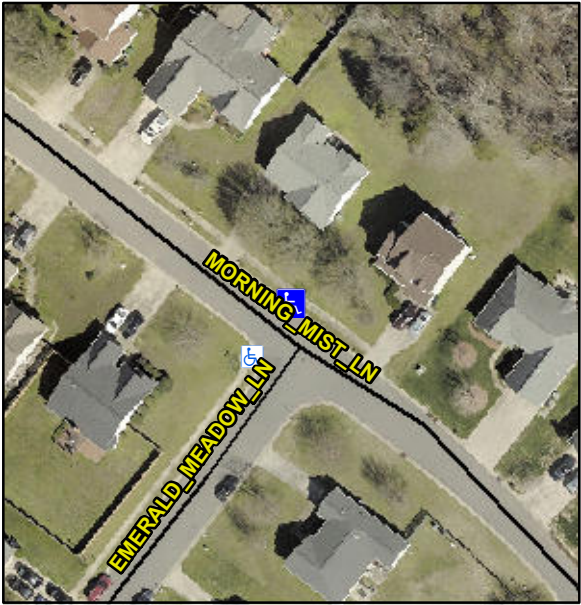
Possible Solutions:		Compliance	Description	Data
	Remove & Replace Entire Ramp.		No	Ramp Length (in)	43.0
			Yes	Ramp Width (in)	48.0
			N/A	Flare Type LT	N/A
			N/A	Flare Slope LT (%)	N/A
			N/A	Flare Traversable LT?	N/A
			N/A	Landing Length (in)	N/A
			N/A	Landing Width (in)	N/A
			N/A	Landing Slope (%)	N/A
			N/A	Landing X Slope (%)	N/A
<p>Surveyor Notes:</p> <p>N/A</p> <p>PROW/ADA:</p> <p>Not Found, R304.2.2, R304.5.3</p>			N/A	Flare Type RT	N/A
			N/A	Flare Slope RT (%)	N/A
			N/A	Flare Traversable RT?	N/A
			N/A	DWS Provided?	N/A
			N/A	DWS Contrast?	N/A
			N/A	DWS Length (in)	N/A
			N/A	DWS Full Width?	N/A
			N/A	DWS Offset (in)	N/A
			N/A	Shared Landing?	N/A
			N/A	Gutter Ponding?	N/A
			N/A	Gutter Lip Ht (in)	N/A
			N/A	Painted X Walk1?	No
				X Walk 1 Direction	To SW
			N/A	X Walk 1 Width (in)	N/A
				X Walk 1 Slope (%)	2.6

X Walk 1 X Slope (%)	0.9
			N/A	Ramp inside XWalk1?	N/A
			N/A	Road Slope (%)	N/A
			N/A	Road X Slope (%)	N/A
			N/A	Any Obstructions?	N/A
				Obstruction Type	
			N/A		
			N/A		
			N/A		
			N/A		
			N/A		
			Yes	Surface Condition? (G/P)	Good
