Access Compliance Report

Public Rights-of-Way

(Curb Ramps)

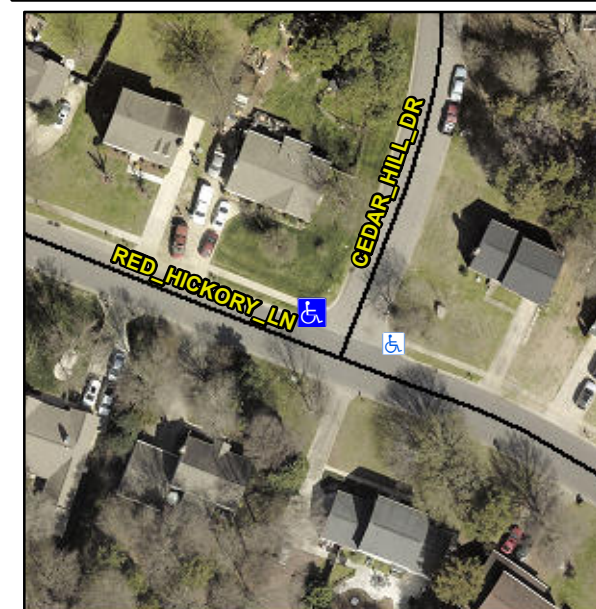
Intersection ID: 20536	Main Street: CEDAR_HILL_DR	Cross Street: RED_HICKORY_LN	Location: NW
ADA ID: 0BAE9FE5D769	Ramp Type: Directional1	Initial Pass/Fail: Fail	Overall Compliance: No
Severity Score: 8.75			
Codes/Mitigation Info/Possible Solution		Field Measurements/Component Compliance

Compliance	Description	Data	Compliance	Description	Data
N/A	Ramp Length (in)	54.0	N/A	Grade Break?	N/A
No	Ramp Width (in)	42.0	N/A	Grade Break Slope (%)	0.0
Yes	Ramp Slope (%)	5.1	N/A	Grade Break XSlope (%)	0.0
Yes	Ramp XSlope (%)	1.0			
N/A	Flare Type LT	N/A	N/A	Flare Type RT	N/A
N/A	Flare Slope LT (%)	N/A	N/A	Flare Slope RT (%)	0.0
N/A	Flare Traversable LT?	N/A	N/A	Flare Traversable RT?	N/A
N/A	Landing Length (in)	0.0	N/A	DWS Provided?	N/A
N/A	Landing Width (in)	0.0	N/A	DWS Contrast?	N/A
N/A	Landing Slope (%)	0.0	N/A	DWS Length (in)	N/A
N/A	Landing X Slope (%)	0.0	N/A	DWS Full Width?	N/A
N/A	Landing Curb? (Y/N)	N/A	N/A	DWS Offset LT (in)	N/A
N/A	Shared Landing?	N/A	N/A	DWS Offset RT (in)	N/A
N/A	Gutter Ponding?	0.0	N/A	Gutter Slope (%)	N/A
N/A	Gutter Lip Ht (in)	0.0	N/A	Gutter X Slope (%)	N/A
N/A	Painted X Walk1?	No		Road Slope (%)	1.9
	X Walk 1 Direction	To E		Road X Slope (%)	1.0
	X Walk 1 Width (in)	N/A		Clear Space?	N/A

X Walk 1 Slope (%)	1.9	N/A	Clear Space to XWalk (in)	N/A
	X Walk 1 X Slope (%)	1.0	N/A	Storm Grate/Utility Hazard?	N/A
N/A	Ramp inside XWalk1?	N/A		Storm Grate/Utility Type	
N/A	Any Obstructions?	N/A			N/A
	Obstruction Type		Yes	Surface Condition? (G/P)	Good
			N/A	Curb Slope (%)	7.7

Possible Solutions:

Remove & Replace Entire Ramp.

R304.5.1
