Access Compliance Report

Public Rights-of-Way

(Curb Ramps)

Intersection ID: 7330	Main Street: HEATHERBROOKE_AV	Cross Street: PONDELLA_DR	Location: SW
ADA ID: 0BAEF6D8AE6A	Ramp Type: Perp	Initial Pass/Fail: Fail	Overall Compliance: No
Severity Score: 21.25			
Codes/Mitigation Info/Possible Solution		Field Measurements/Component Compliance

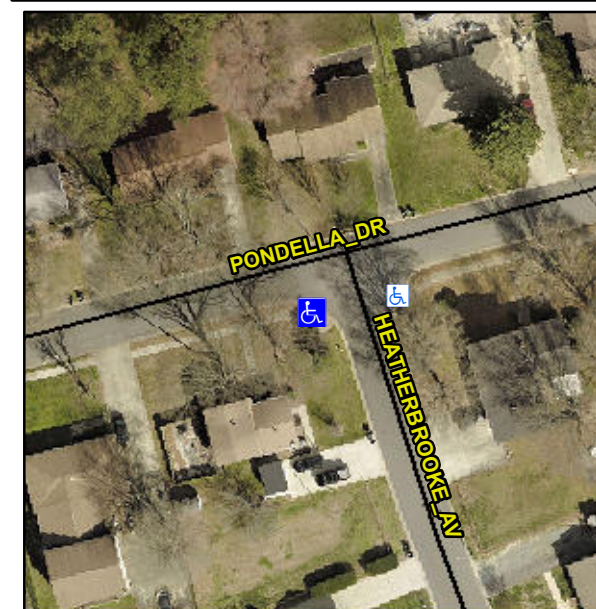
Not Found, R304.5.1, R304.2.2

Compliance	Description	Data	Compliance	Description	Data
N/A	Ramp Length (in)	48.0	No	Ramp Slope (%)	8.4
No	Ramp Width (in)	38.0	Yes	Ramp XSlope (%)	1.4
N/A	Flare Type LT	N/A	N/A	Flare Type RT	N/A
N/A	Flare Slope LT (%)	N/A	N/A	Flare Slope RT (%)	N/A
N/A	Flare Traversable LT?	N/A	N/A	Flare Traversable RT?	N/A
N/A	Landing Length (in)	N/A	N/A	DWS Provided?	N/A
N/A	Landing Width (in)	N/A	N/A	DWS Contrast?	N/A
N/A	Landing Slope (%)	N/A	N/A	DWS Length (in)	N/A
N/A	Landing X Slope (%)	N/A	N/A	DWS Full Width?	N/A
N/A	Landing Curb? (Y/N)	N/A	N/A	DWS Offset (in)	N/A
N/A	Shared Landing?	N/A			
N/A	Gutter Ponding?	N/A	N/A	Gutter Slope (%)	N/A
N/A	Gutter Lip Ht (in)	N/A	N/A	Gutter X Slope (%)	N/A
N/A	Painted X Walk1?	No	N/A	Painted X Walk2?	N/A
	X Walk 1 Direction	To E		X Walk 2 Direction	N/A
N/A	X Walk 1 Width (in)	N/A	N/A	X Walk 2 Width (in)	N/A
	X Walk 1 Slope (%)	4.4		X Walk 2 Slope (%)	N/A
	X Walk 1 X Slope (%)	0.4		X Walk 2 X Slope (%)	N/A

N/A	Ramp inside XWalk1?	N/A	N/A	Ramp inside XWalk2?	N/A
	Road Slope (%)	N/A	N/A	Clear Space?	N/A
	Road X Slope (%)	N/A	N/A	Clear Space to XWalk (in)	N/A
N/A	Any Obstructions?	N/A	N/A	Storm Grate/Utility Hazard?	N/A
	Obstruction Type			Storm Grate/Utility Type	
		N/A			N/A
			Yes	Surface Condition? (G/P)	Good

Possible Solutions:

Remove & Replace Entire Ramp.

Total Cost: \$ 1850.00
